SANITARY SEWER SYSTEM INVESTIGATION

Minuteman and Shattuck Road area
Andover, MA

Sewer Video Investigation Conducted by:
BMC Corp., Billerica, MA

Coordinated by:
LINDEN ENGINEERING PARTNERS, LLC
100 TradeCenter, Suite G700
Woburn, MA 01801

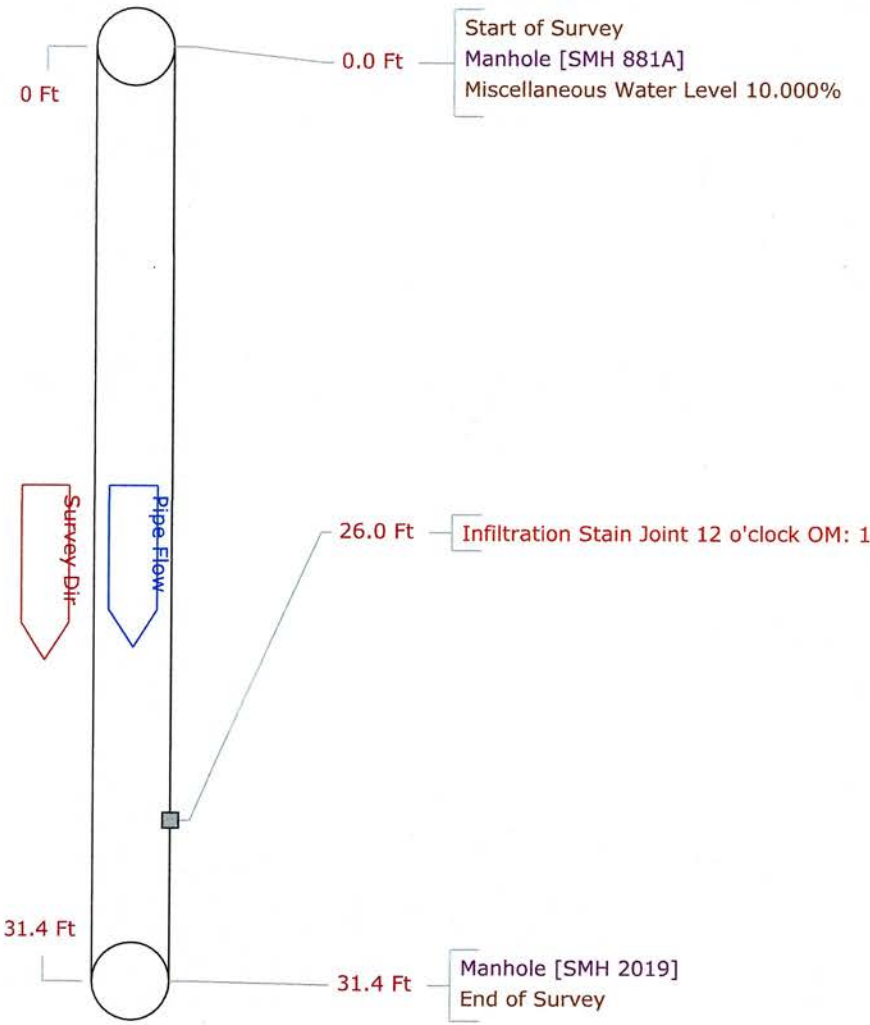
Pipe Graphic Report of PLR SMH 881A

Count	Video	CD Code	Val1	Val2	%	Jnt	Fr	To	ImRef	Remarks
0.0		ST								Start of Survey
0.0		AMH								Manhole SMH 881A
0.0		MWL			10.000					Miscellaneous Water Level
26.0		ISJ				J	12			Infiltration Stain Joint
31.4		AMH								Manhole SMH 2019
31.4		FH								End of Survey

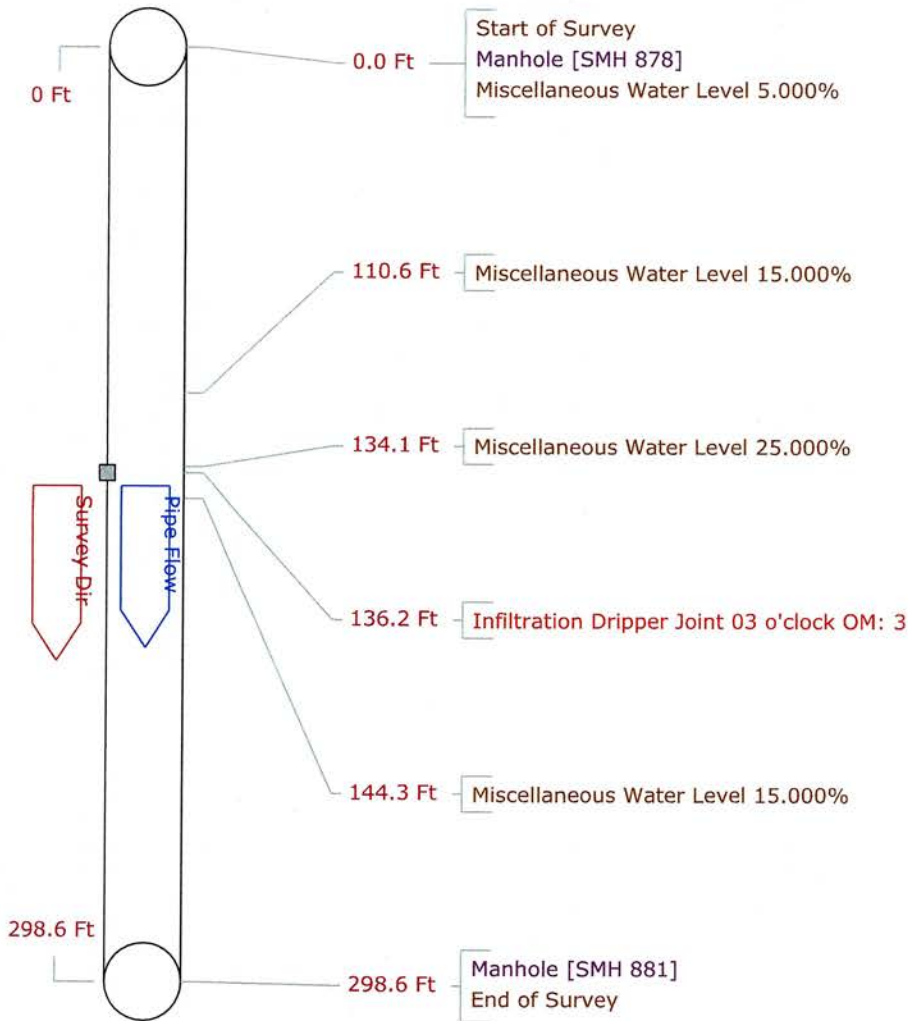
Tabular Report of PSR SMH 878

Count	Video	CD Code	Val1	Val2	%	Jnt	Fr	To	ImRef	Remarks
0.0		ST								Start of Survey
0.0		AMH								Manhole SMH 878
0.0		MWL			5.000					Miscellaneous Water Level
110.6		MWL			15.000					Miscellaneous Water Level
134.1		MWL			25.000					Miscellaneous Water Level
136.2		IDJ				J	03			Infiltration Dripper Joint
144.3		MWL			15.000					Miscellaneous Water Level
298.6		AMH								Manhole SMH 881
298.6		FH								End of Survey

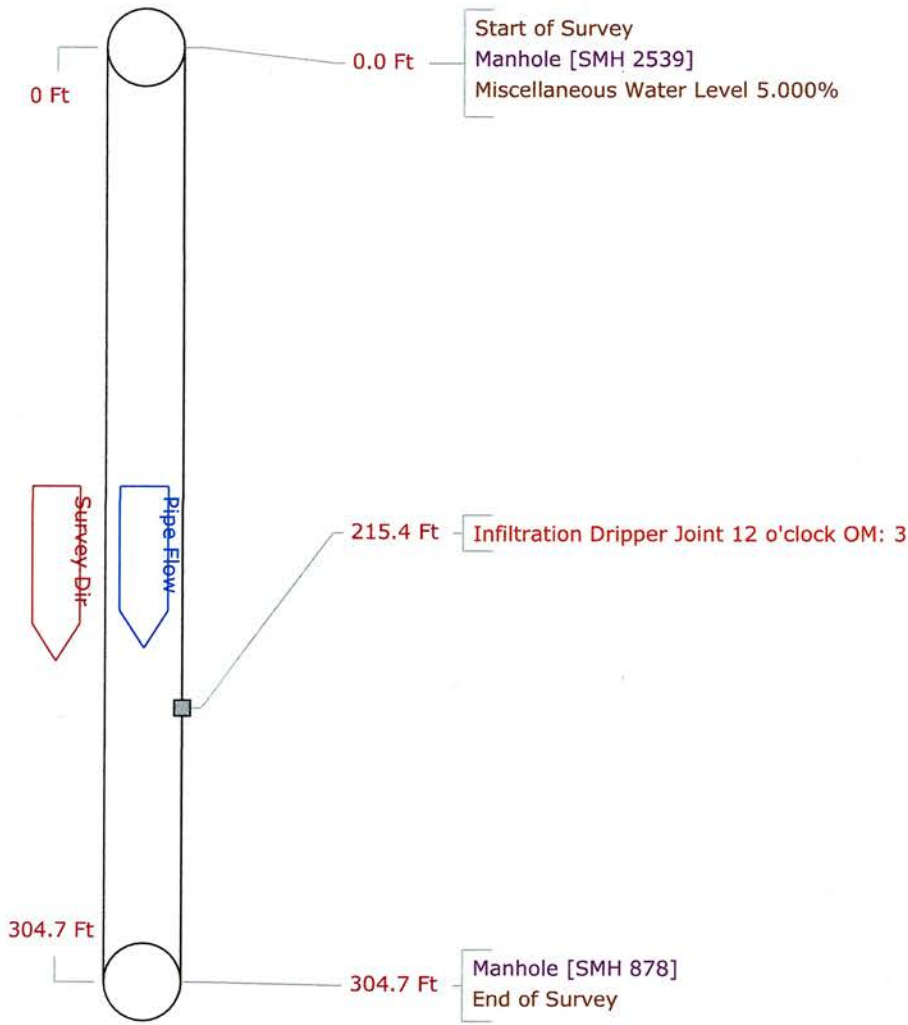
Tabular Report of PSR SMH 2539 for Liden Engineering

Count	Video	CD	Code	Val1	Val2	%	Jnt	Fr	To	ImRef	Remarks
0.0			ST Start of Survey								
0.0			AMH Manhole								SMH 2539
0.0			MWL Miscellaneous Water Level			5.000					
215.4			IDJ Infiltration Dripper Joint				J	12			
304.7			AMH Manhole								SMH 878
304.7			FH End of Survey

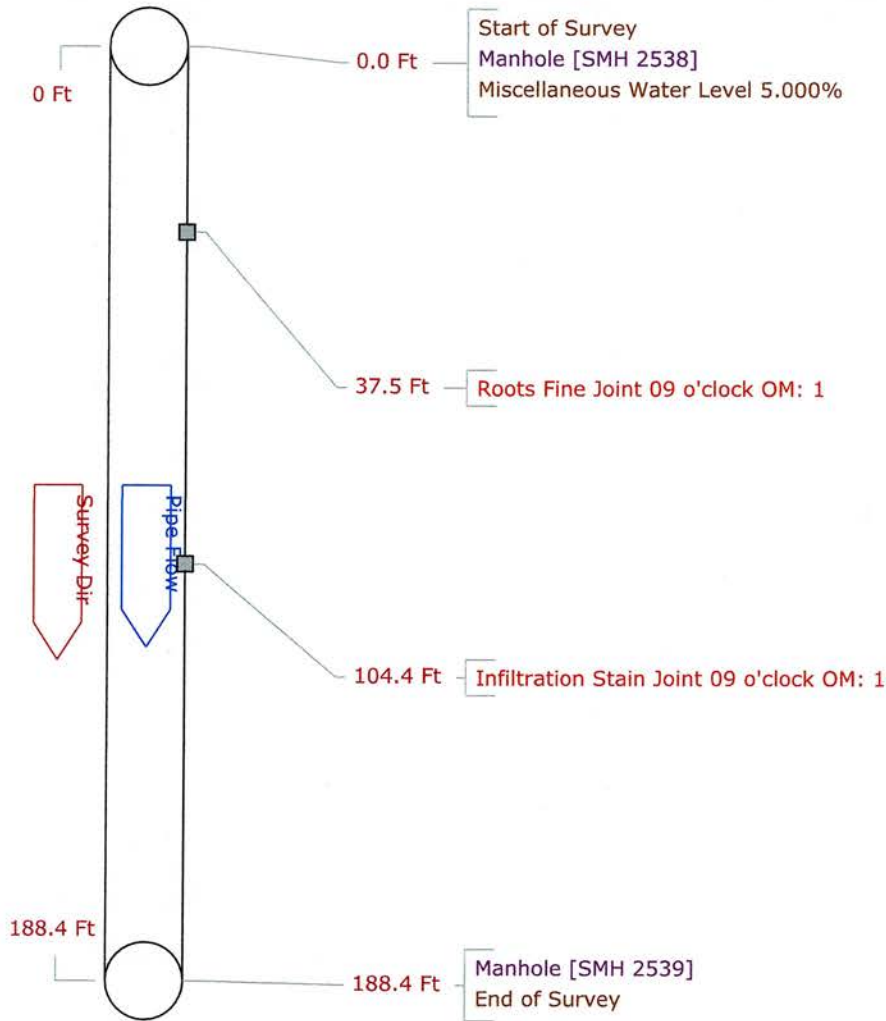
Tabular Report of PSR SMH 2538

Count	Video	CD Code	Val1	Val2	%	Jnt	Fr	To	ImRef	Remarks
0.0		ST Start of Survey								
0.0		AMH Manhole								SMH 2538
0.0		MWL Miscellaneous Water Level			5.000					
37.5		RFJ Roots Fine Joint				J	09			
104.4		ISJ Infiltration Stain Joint				J	09			
188.4		AMH Manhole								SMH 2539
188.4		FH End of Survey

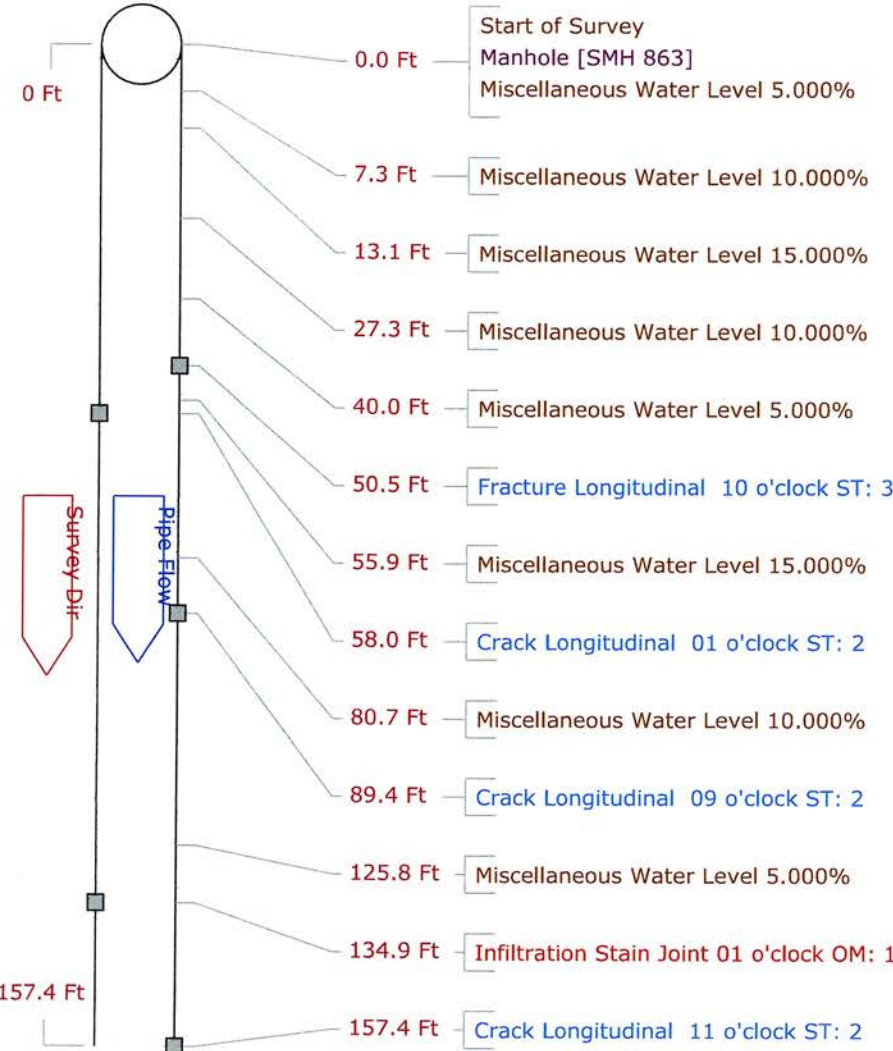
Count	Video	CD Code	Val1	Val2	%	Jnt	Fr	To	ImRef	Remarks
0.0		ST Start of Survey								
0.0		AMH Manhole								SMH 863
0.0		MWL Miscellaneous Water Level			5.000					
7.3		MWL Miscellaneous Water Level			10.000					
13.1		MWL Miscellaneous Water Level			15.000					
27.3		MWL Miscellaneous Water Level			10.000					
40.0		MWL Miscellaneous Water Level			5.000					
50.5		FL Fracture Longitudinal					10			
55.9		MWL Miscellaneous Water Level			15.000					
58.0		CL Crack Longitudinal					01			
80.7		MWL Miscellaneous Water Level			10.000					
89.4		CL Crack Longitudinal					09			
125.8		MWL Miscellaneous Water Level			5.000					
134.9		ISJ Infiltration Stain Joint				J	01			
157.4		CL Crack Longitudinal					11			
158.2		AMH Manhole								SMH 872
158.2		FH End of Survey
