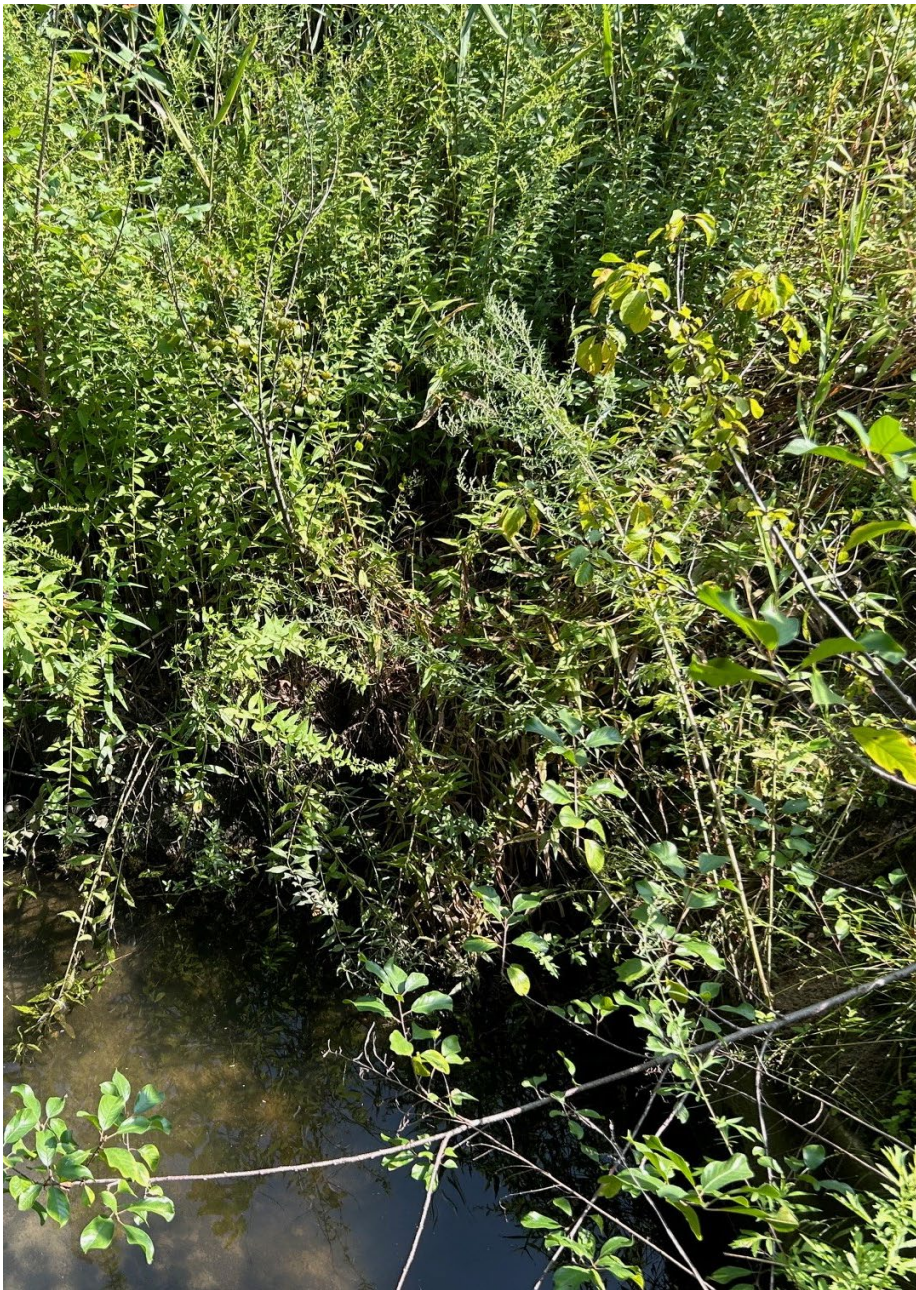
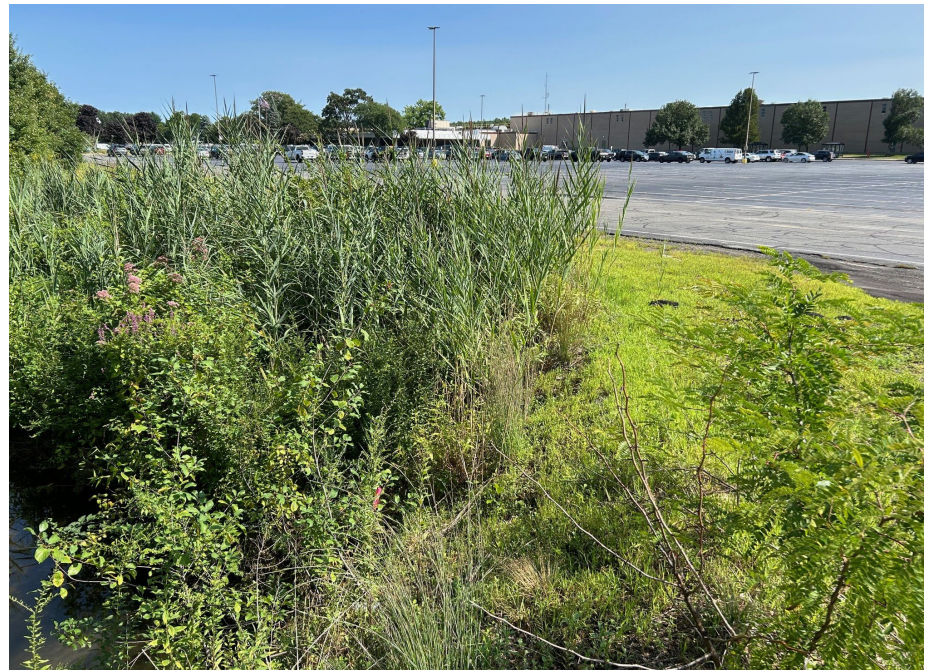
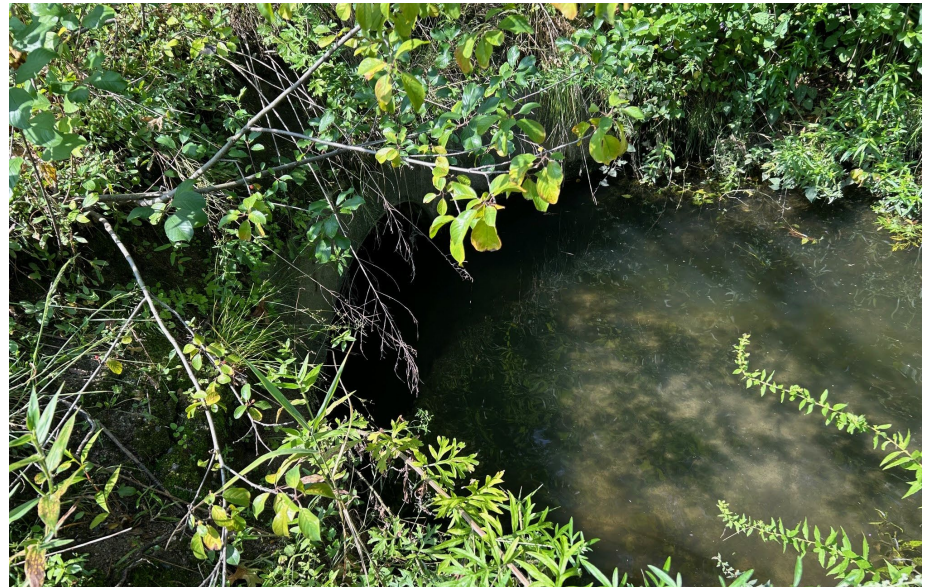
Typical views of existing conditions at the existing 48-inch diameter culvert (no evidence of erosion from scouring).
