**Norse Environmental Services, Inc.**  
2100 Lakeview Avenue, Unit 3A  
Dracut, MA 01826  
Ph: (978) 649-9932  
Website: [www.norseenvironmental.com](http://www.norseenvironmental.com)

Re: 9 Bancroft Road  
Andover, MA 01810

Per your 9-17-24 email request, Norse Environmental Services, Inc., performed a third site visit at the above property on 9-21-24. I inspected the area along the property line of the Bancroft Elementary School where you noted, “leaf staining, trees with buttressed roots and at least two drains.” You provided the yellow circled areas on the aerial image below which are the locations I field investigated. I refer to these areas as the “areas of concern”.

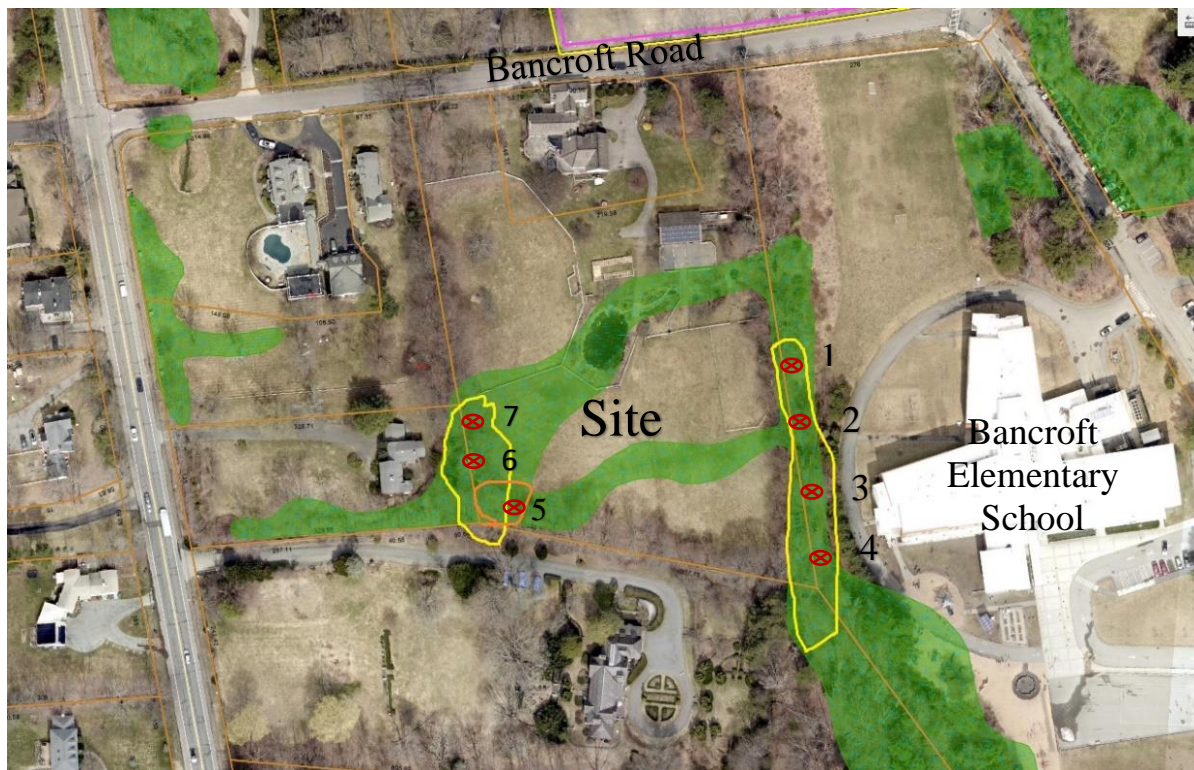
I walked the entire yellow circled area, along the school property line and investigated (4) different locations (numbered as red dots ⊗) on the aerial image. I augured in (3) of these locations to a minimum of 20”. Please see my findings on the following pages.

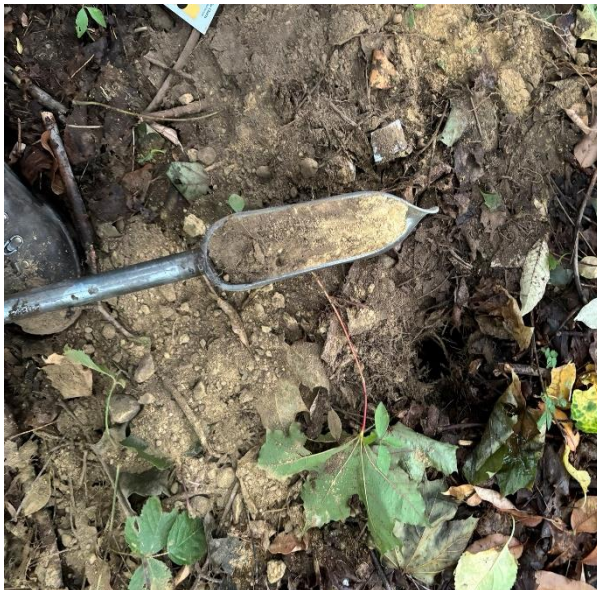
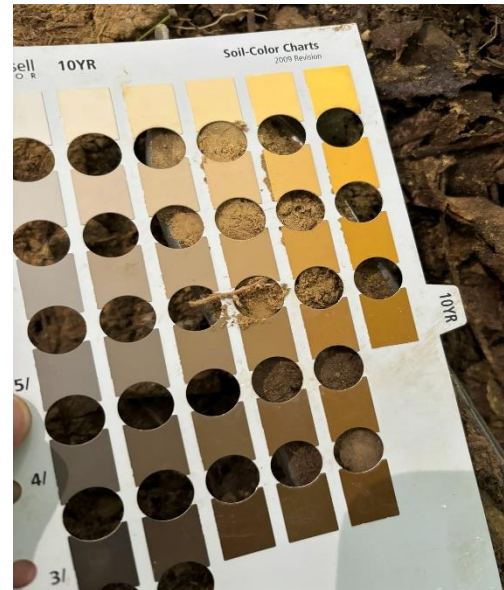
1. At the first location I observed upland vegetation and upland (non-hydric) soils. The overstory is dominated by Norway maple (*Acer platanoides*) with a few black cherry (*Prunus serotina*) trees. The understory consists of burning bush (*Euonymus occidentalis*) and multiflora rose (*Rosa multiflora*). The herbaceous layer was lacking vegetation, and the vine layer consists of oriental bittersweet (*Celastrus orbiculatus*). The vegetation is categorized as upland plants per the U.S. Army Corps of Engineers 2020, Northcentral and Northeast Region, National Wetland Plant List, version 3.5.

I augered to 20” and observed the following upland (non-hydric) soil profile.

Depth (in)	Soil Horizon/Layer	Soils Texture (USDA)	Soil Matrix	Redoximorphic Features
0-10”	Ap	FSL	10YR 2/2	None
10-20”	Bw	FSL	10 YR 6/6	None

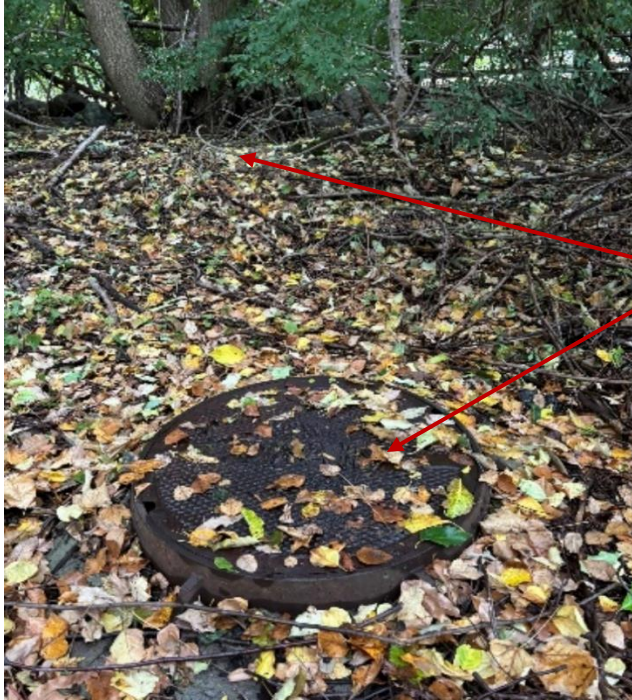
The area is disturbed or altered most likely from the installation of the drain manhole

nearby. In addition, I observed a pile of fill near the drain manhole. Please see the photographs on the following page.

Pile of fill and drain manhole on the Bancroft School property.

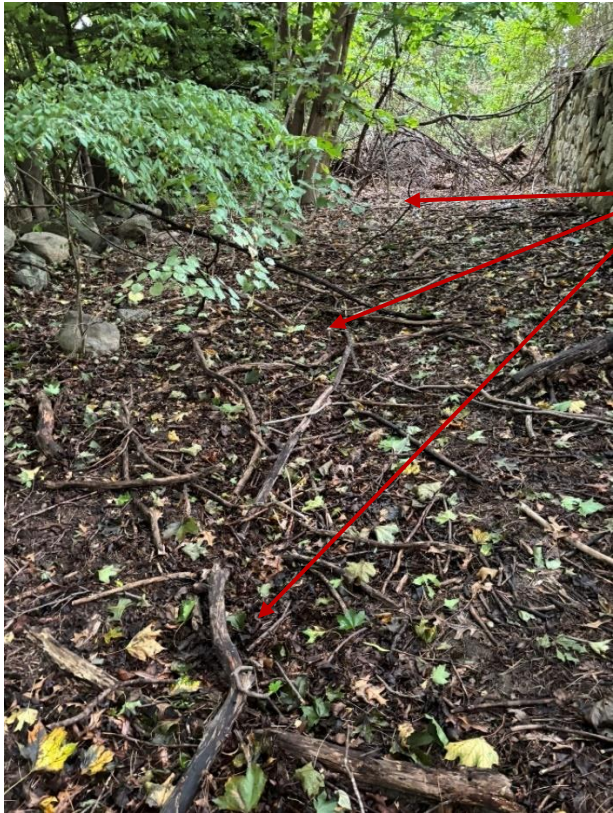
3. At the third location, I observed a man-made ditch or swale, located on the property, which directs surface water into the series of catch basins near the property line. I did not observe any wetland or hydric vegetation within or around the swale.

Man-made swale that directs stormwater into the catch basins on the Bancroft School Property. Please note the stone retaining wall in the background.

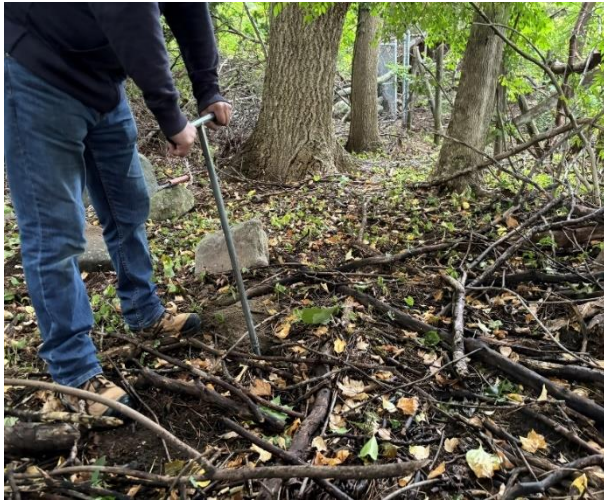
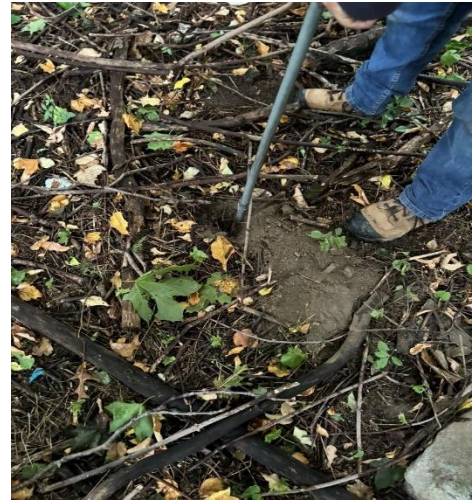
4. The fourth location is near the property line or near the “buttressed”/shallow rooted Norway maple. The overstory is dominated by Norway maple and understory consists of burning bush. The herbaceous layer is lacking except for some garlic mustard (*Alliaria petiolata*). These plants are characterized as upland plants.

Depth (in)	Soil Horizon/Layer	Soils Texture (USDA)	Soil Matrix	Redoximorphic Features
0-20”	Fill	Gravelly SL	10YR 2/2	None

The area is disturbed or altered, most likely from the installation of the nearby catch basin.

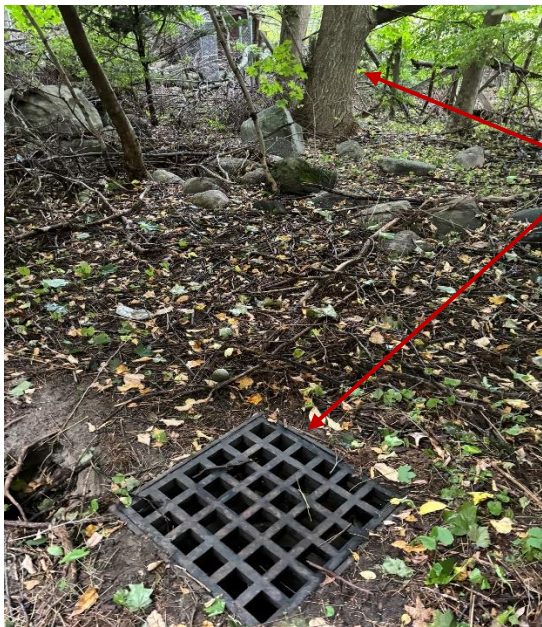
Norway maple with “buttressed”/shallow roots and catch basin.

Mr. Douglas, you note the observation of leaf staining, I did not observe any leaf staining. I did observe a man-made ditch or swale that directs water into the series of catch basins on the property. Regarding trees with buttressed or shallow root system, this can be an indicator of wetland hydrology and is common in forested wetlands. However, shallow root systems can also form in upland areas where bedrock is close to the surface or within stony soils. It is my opinion that the shallow roots are a result of the stony soils exhibited throughout the site. This would explain the field stone walls along the property line.

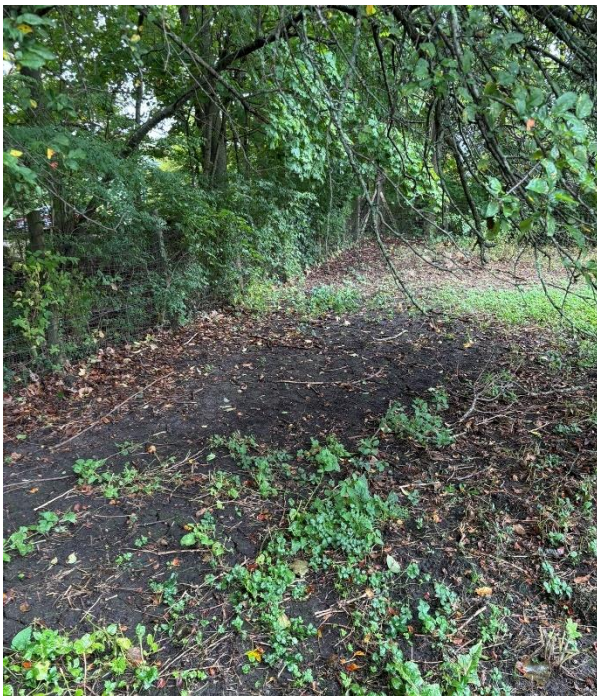
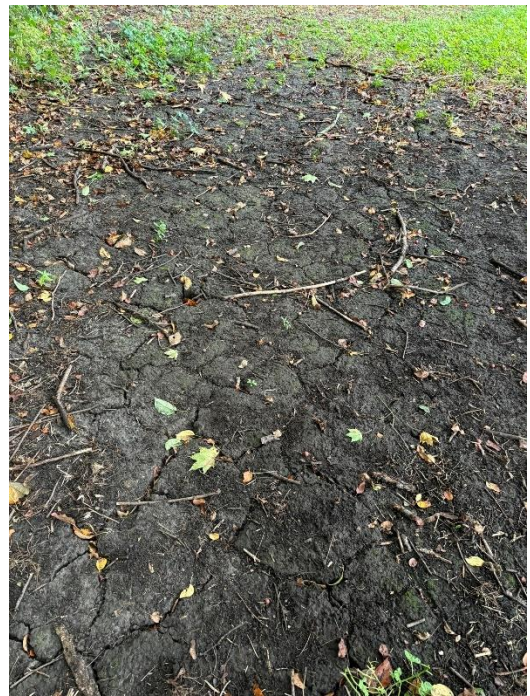
5. The fifth location is a low area, which collects and holds water, due to the existing sloping topography and surrounding stone walls. Please see the photograph below:

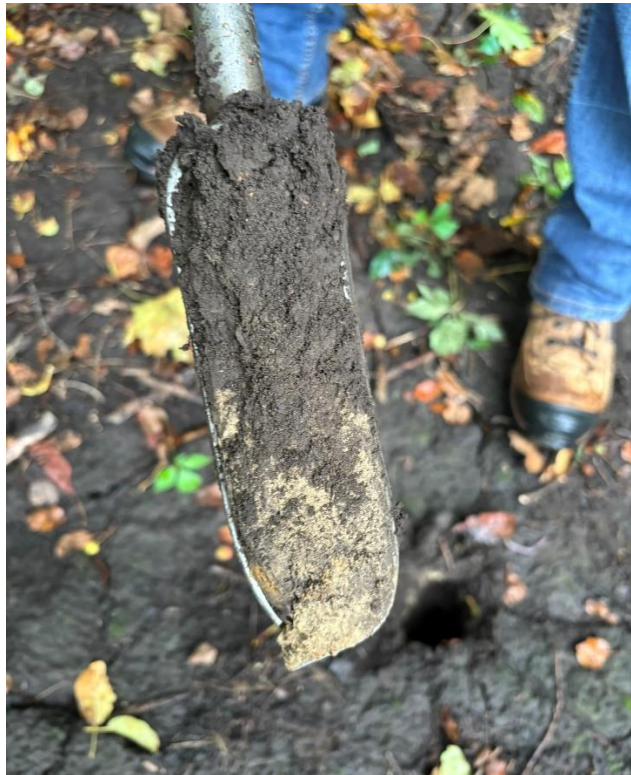
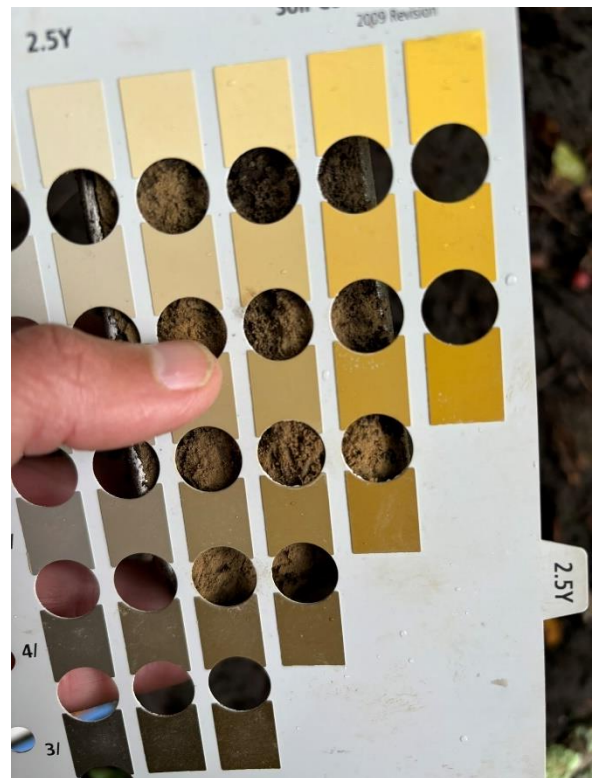
Depth (in)	Soil Horizon/Layer	Soils Texture (USDA)	Soil Matrix	Redoximorphic Features
0-12"	Ap	FSL	10YR 2/2	None
12-22"	Bw	FSL	2.5Y 4/4	7.5YR 6/6

Although I noted some redoximorphic features within the Bw horizon the matrix color is too bright to be considered a wetland or hydric soil. Please see the photograph below:

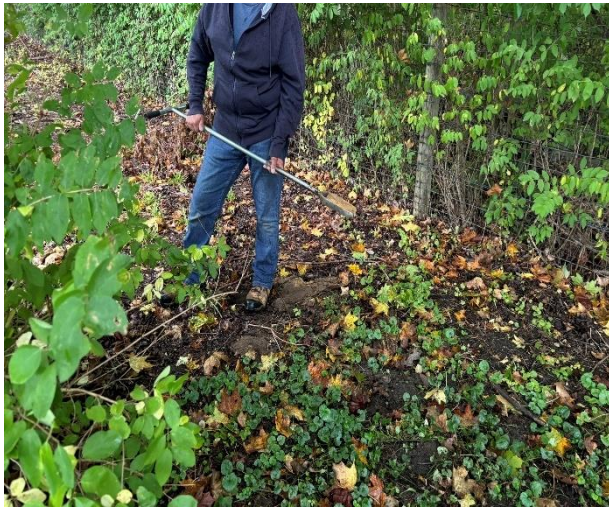
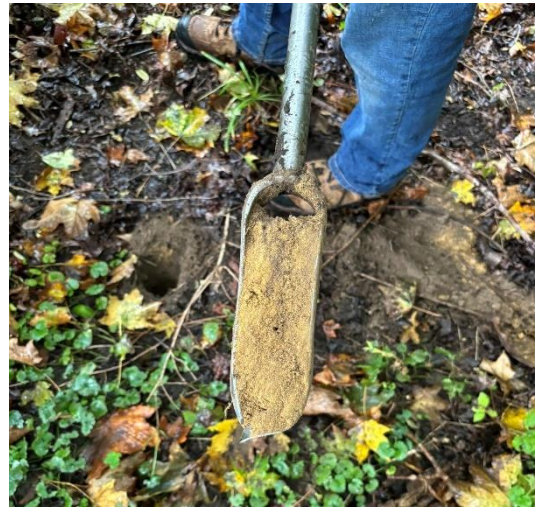
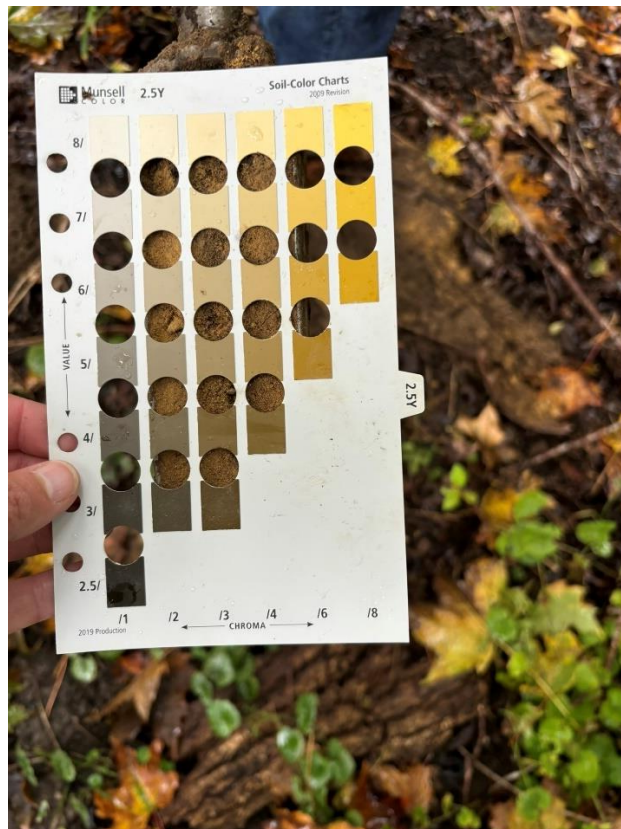
- The sixth location is approximately 48 ft. from the southerly property line and 6 ft. from the fence. I noted a dominance of Norway maple and some crabapple trees in the overstory. The understory consists of honeysuckle and the herbaceous layer consists of garlic mustard and nightshade (*Solanum* sp.). The vegetation is classified as upland plants.

Depth (in)	Soil Horizon/Layer	Soils Texture (USDA)	Soil Matrix	Redoximorphic Features
0-12”	Ap	FSL	10YR 2/2	None
12-20”	Bw	FSL	2.5Y 4/4	None

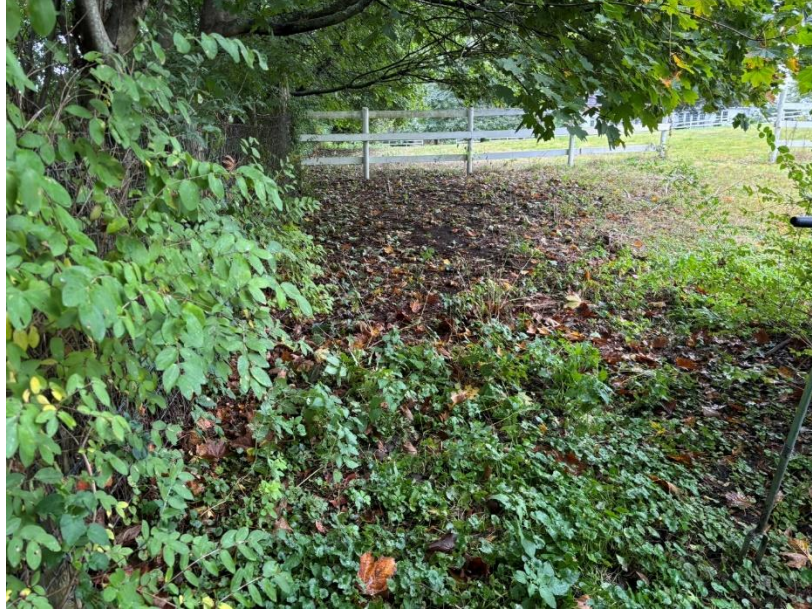
7. The last location I observed has similar vegetation as noted throughout this report. Due to the rocky soils, I was unable to auger down to 20". I observed the topsoil color as 10YR 2/2 with no redoximorphic features. I did not observe wetland or hydric plants. Please see the photograph below:
