SANITARY SEWER SYSTEM INVESTIGATION

Minuteman and Shattuck Road area
Andover, MA

Sewer Video Investigation Conducted by:
BMC Corp., Billerica, MA

Coordinated by:
LINDEN ENGINEERING PARTNERS, LLC
100 TradeCenter, Suite G700
Woburn, MA 01801

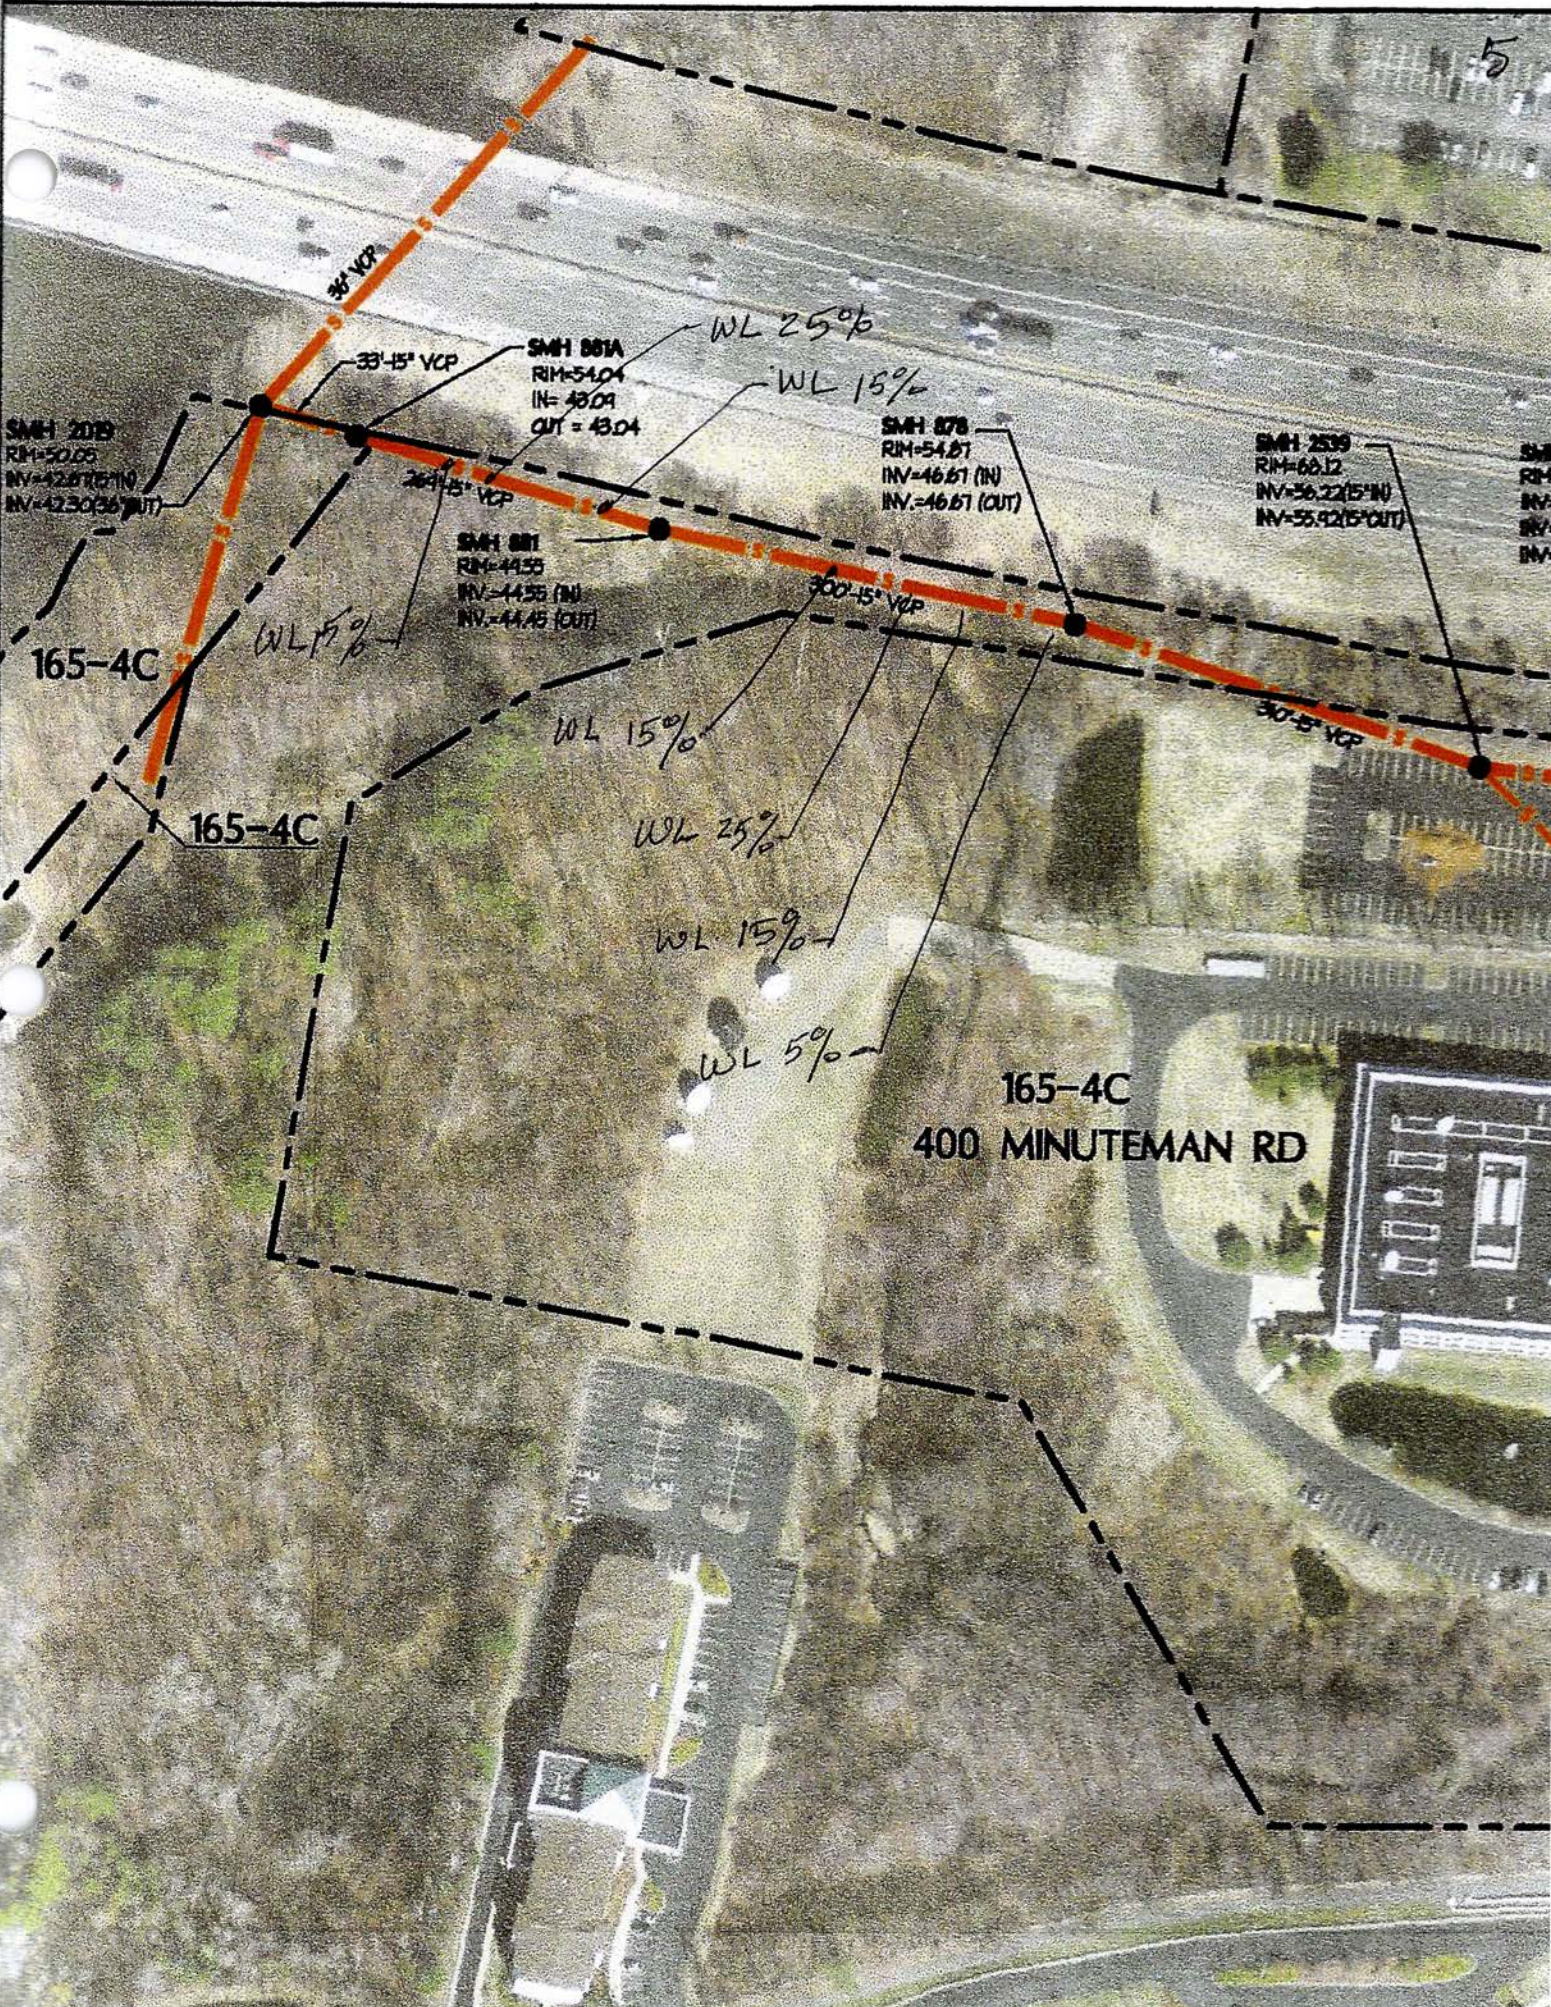
Pipe Graphic Report of PLR SMH 881A

Count	Video	CD Code	Val1	Val2	%	Jnt	Fr	To	ImRef	Remarks
0.0		ST								Start of Survey
0.0		AMH								Manhole SMH 881A
0.0		MWL			10.000					Miscellaneous Water Level
26.0		ISJ				J	12			Infiltration Stain Joint
31.4		AMH								Manhole SMH 2019
31.4		FH								End of Survey

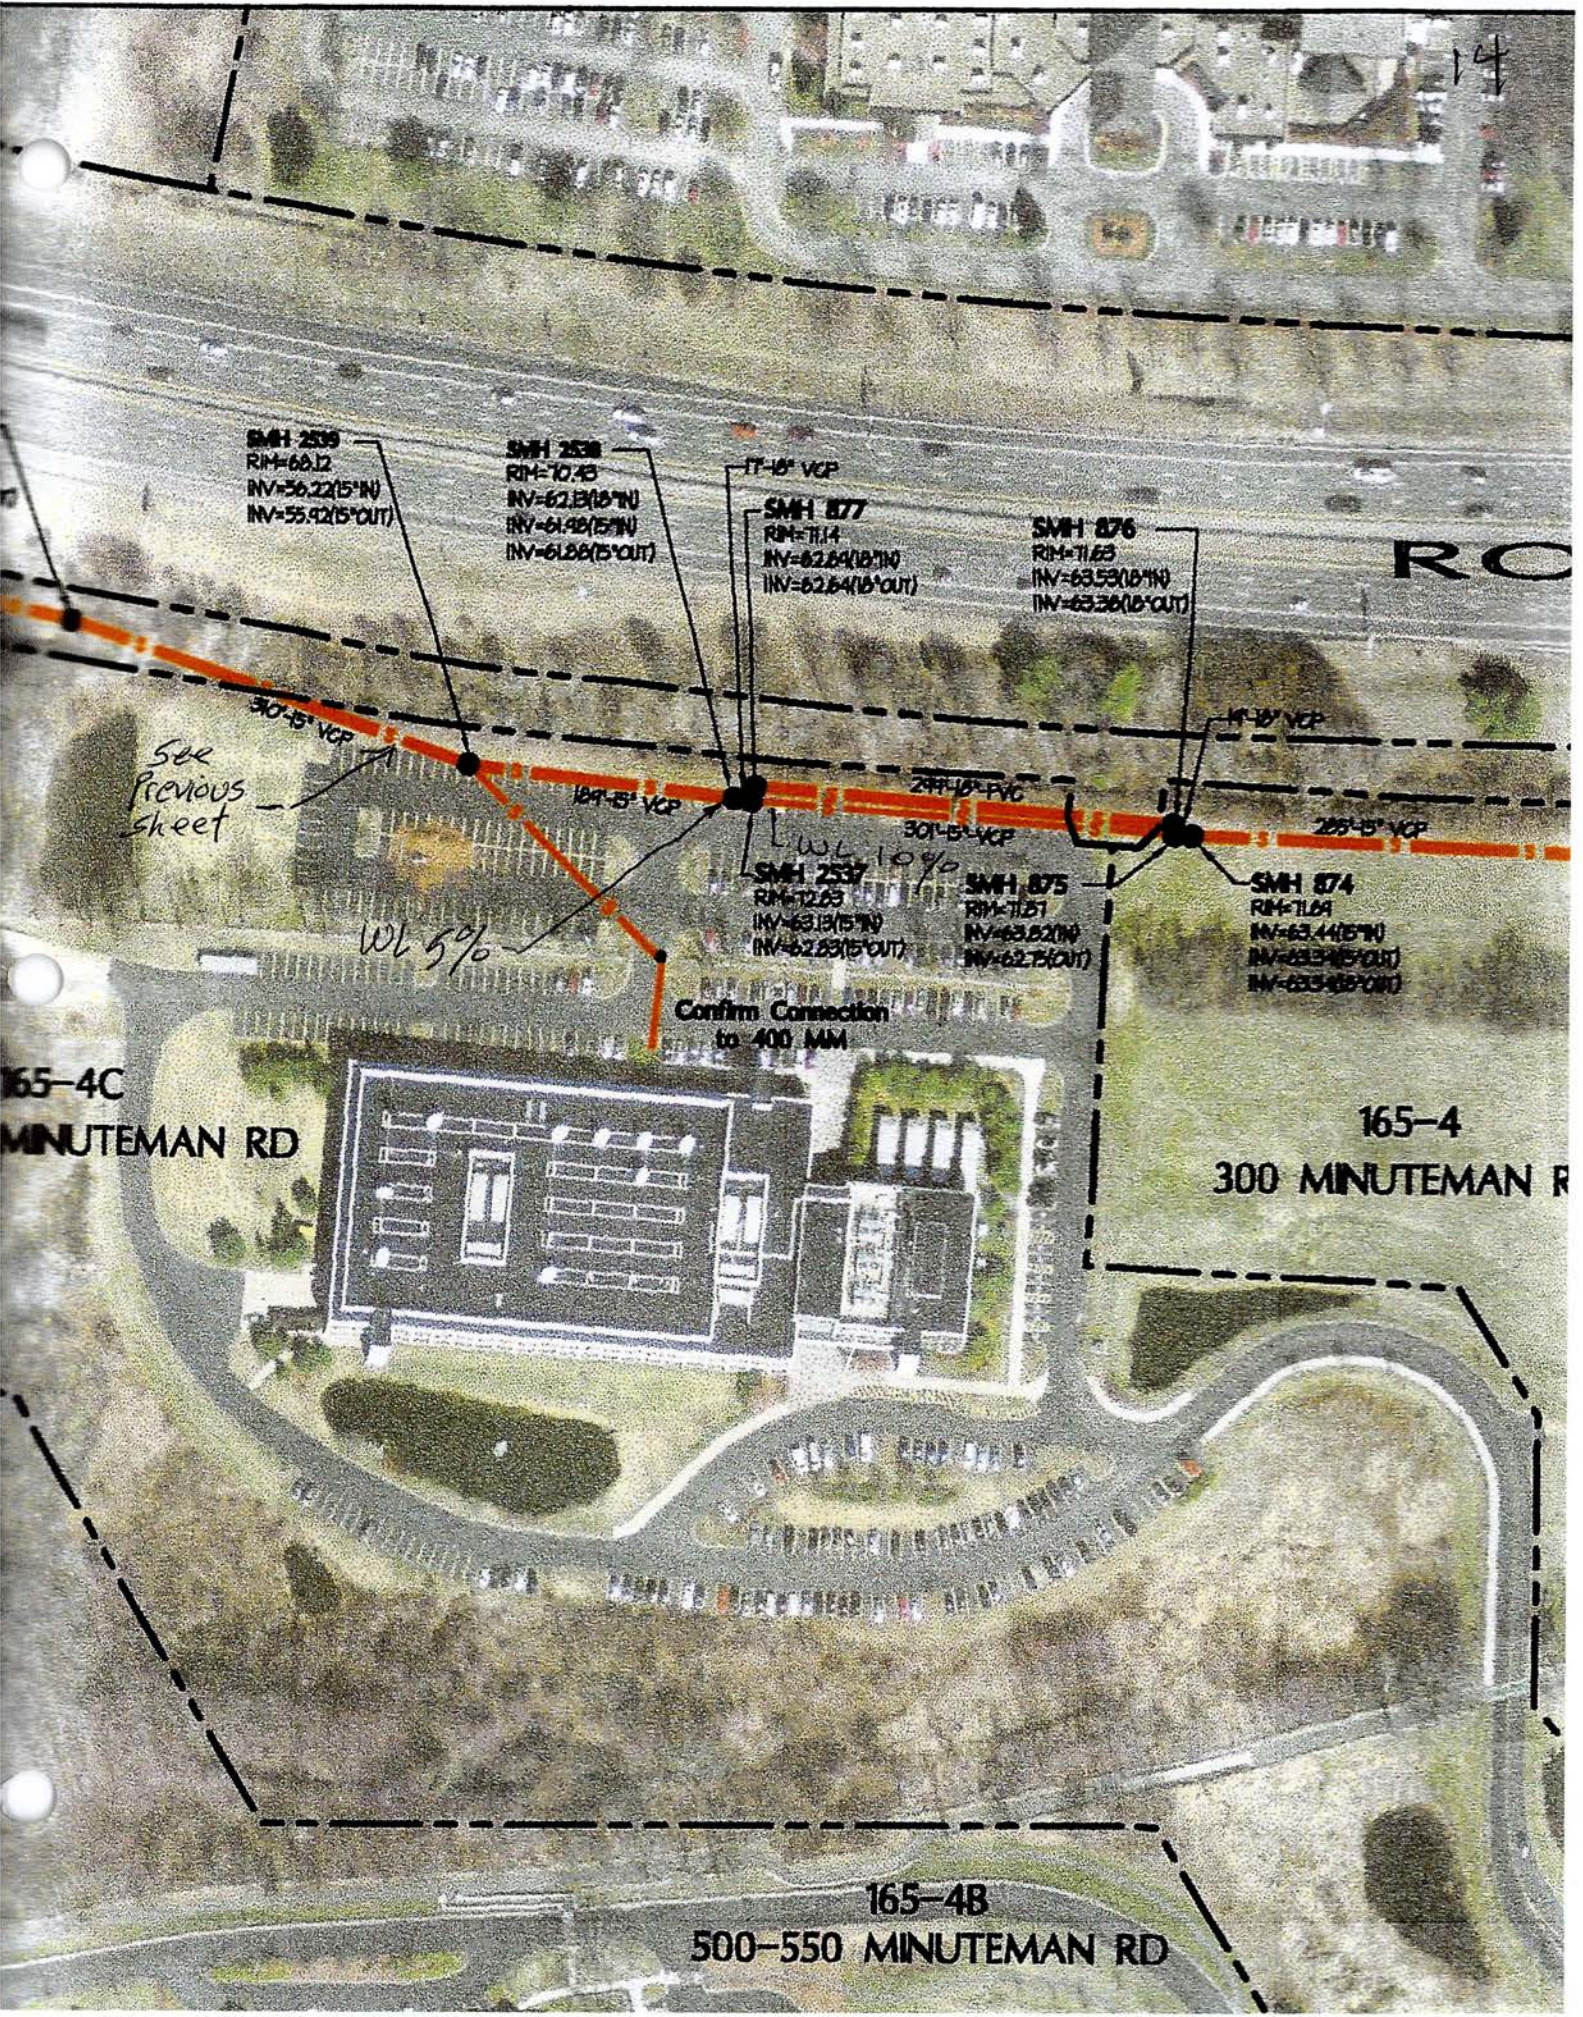
Pipe Graphic Report of PLR SMH 2538

Count	Video	CD Code	Val1	Val2	%	Jnt	Fr	To	ImRef	Remarks
0.0		ST Start of Survey								
0.0		AMH Manhole								SMH 2538
0.0		MWL Miscellaneous Water Level			5.000					
37.5		RFJ Roots Fine Joint				J	09			
104.4		ISJ Infiltration Stain Joint				J	09			
188.4		AMH Manhole								SMH 2539
188.4		FH End of Survey

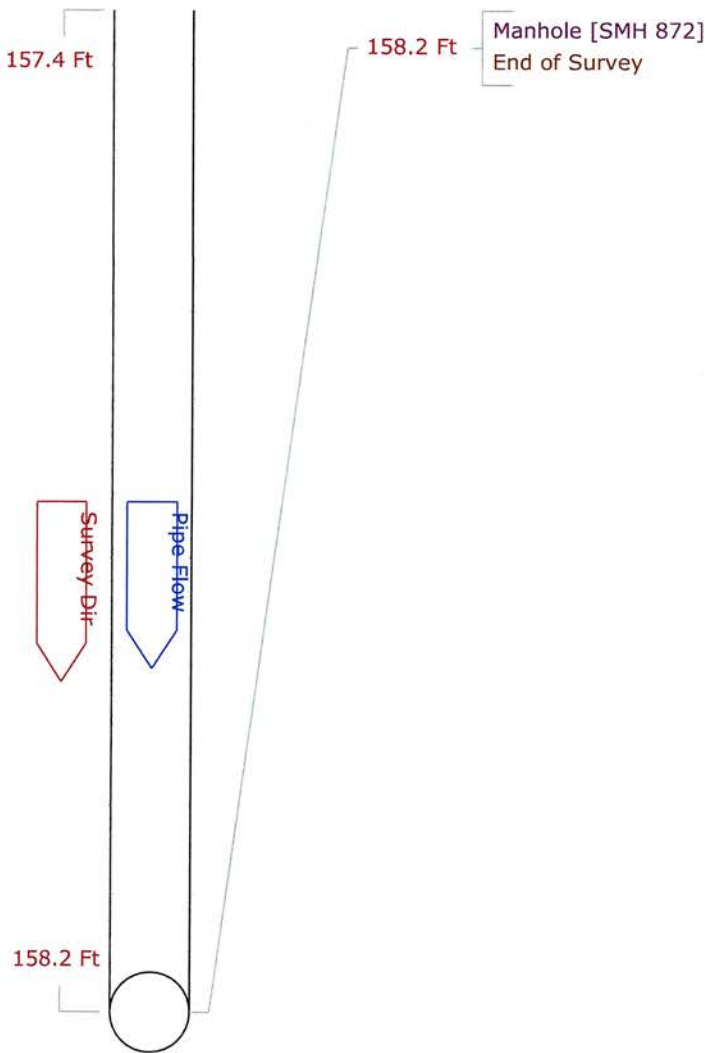
Tabular Report of PSR SMH 863

Count	Video	CD Code	Val1	Val2	%	Jnt	Fr	To	ImRef	Remarks
0.0		ST Start of Survey								
0.0		AMH Manhole								SMH 863
0.0		MWL Miscellaneous Water Level			5.000					
7.3		MWL Miscellaneous Water Level			10.000					
13.1		MWL Miscellaneous Water Level			15.000					
27.3		MWL Miscellaneous Water Level			10.000					
40.0		MWL Miscellaneous Water Level			5.000					
50.5		FL Fracture Longitudinal					10			
55.9		MWL Miscellaneous Water Level			15.000					
58.0		CL Crack Longitudinal					01			
80.7		MWL Miscellaneous Water Level			10.000					
89.4		CL Crack Longitudinal					09			
125.8		MWL Miscellaneous Water Level			5.000					
134.9		ISJ Infiltration Stain Joint				J	01			
157.4		CL Crack Longitudinal					11			
158.2		AMH Manhole								SMH 872
158.2		FH End of Survey

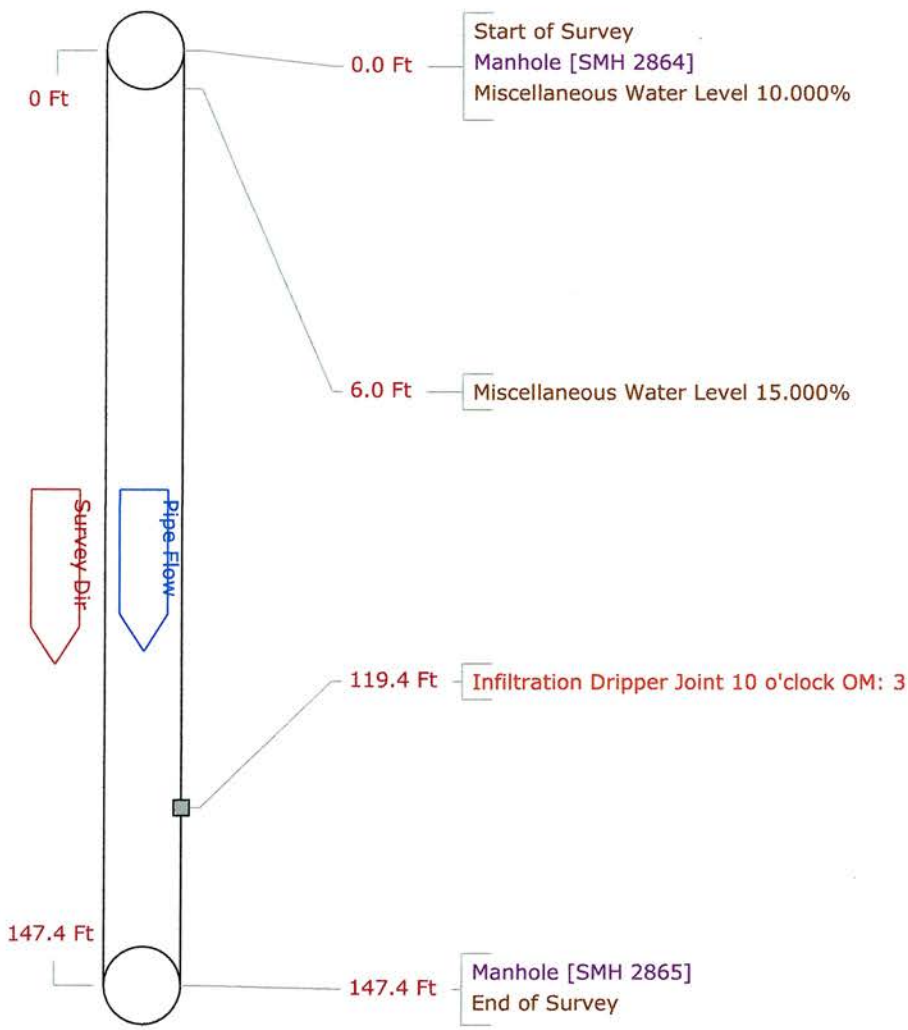
Tabular Report of PSR SMH 2864 for Liden Engineering

Count Video	CD Code	Val1	Val2	%	Jnt	Fr	To	ImRef	Remarks
0.0	ST Start of Survey								
0.0	AMH Manhole								SMH 2864
0.0	MWL Miscellaneous Water Level			10.000					
6.0	MWL Miscellaneous Water Level			15.000					
119.4	IDJ Infiltration Dripper Joint				J	10			
147.4	AMH Manhole								SMH 2865
147.4	FH End of Survey

Scores	Structural: Pipe Rating 0	Pipe Ratings Index 0	Quick Rating 0000
	O&M: Pipe Rating 3	Pipe Ratings Index 3	Quick Rating 3100
	Overall Pipe Rating 3	Pipe Ratings Index 3	Quick Rating 3100

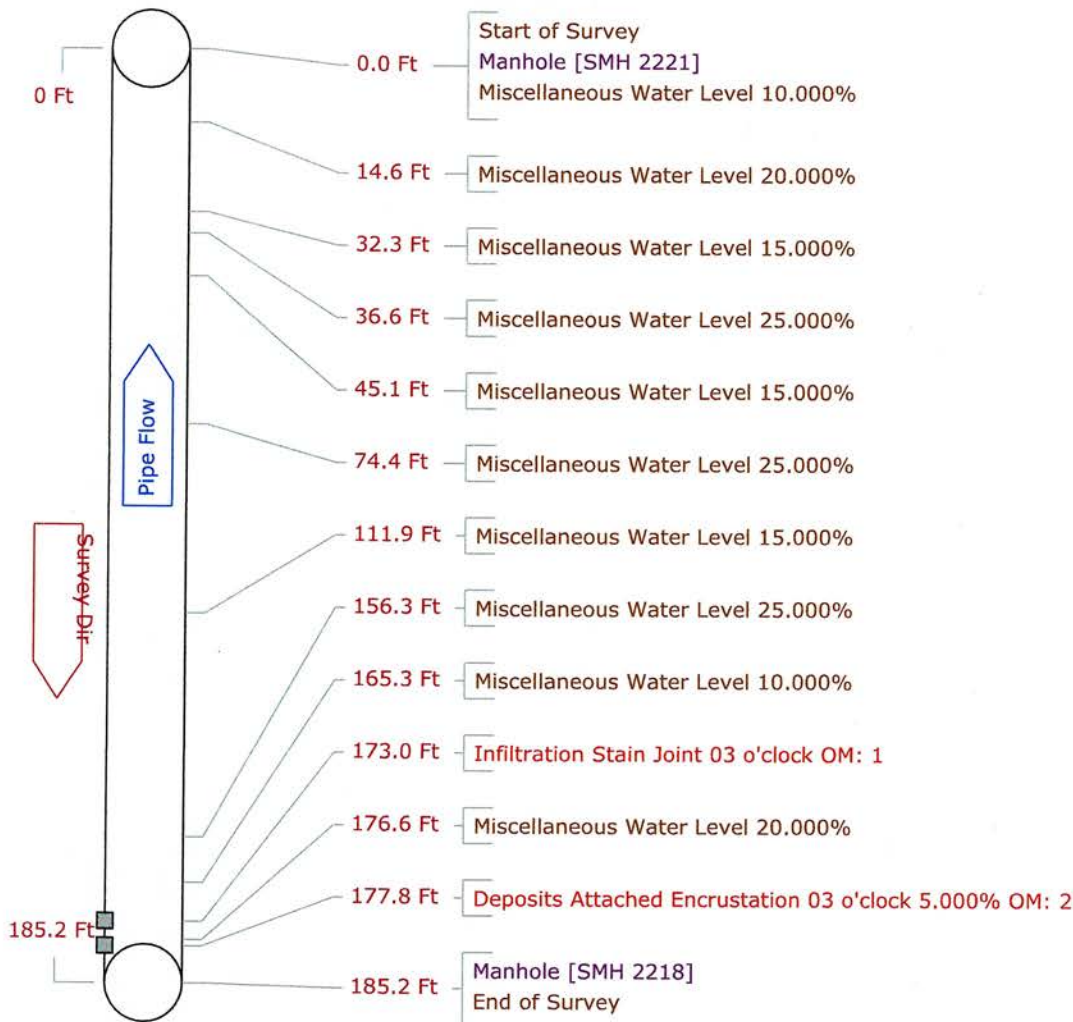
Tabular Report of PSR SMH 2218

Count	Video	CD Code	Val1	Val2	%	Jnt	Fr	To	ImRef	Remarks
0.0		ST								Start of Survey
0.0		AMH								Manhole SMH 2221
0.0		MWL			10.000					Miscellaneous Water Level
14.6		MWL			20.000					Miscellaneous Water Level
32.3		MWL			15.000					Miscellaneous Water Level
36.6		MWL			25.000					Miscellaneous Water Level
45.1		MWL			15.000					Miscellaneous Water Level
74.4		MWL			25.000					Miscellaneous Water Level
111.9		MWL			15.000					Miscellaneous Water Level
156.3		MWL			25.000					Miscellaneous Water Level
165.3		MWL			10.000					Miscellaneous Water Level
173.0		ISJ					J	03		Infiltration Stain Joint
176.6		MWL			20.000					Miscellaneous Water Level
177.8		DAE			5.000			03		Deposits Attached Encrustation
185.2		AMH								Manhole SMH 2218
185.2		FH								End of Survey

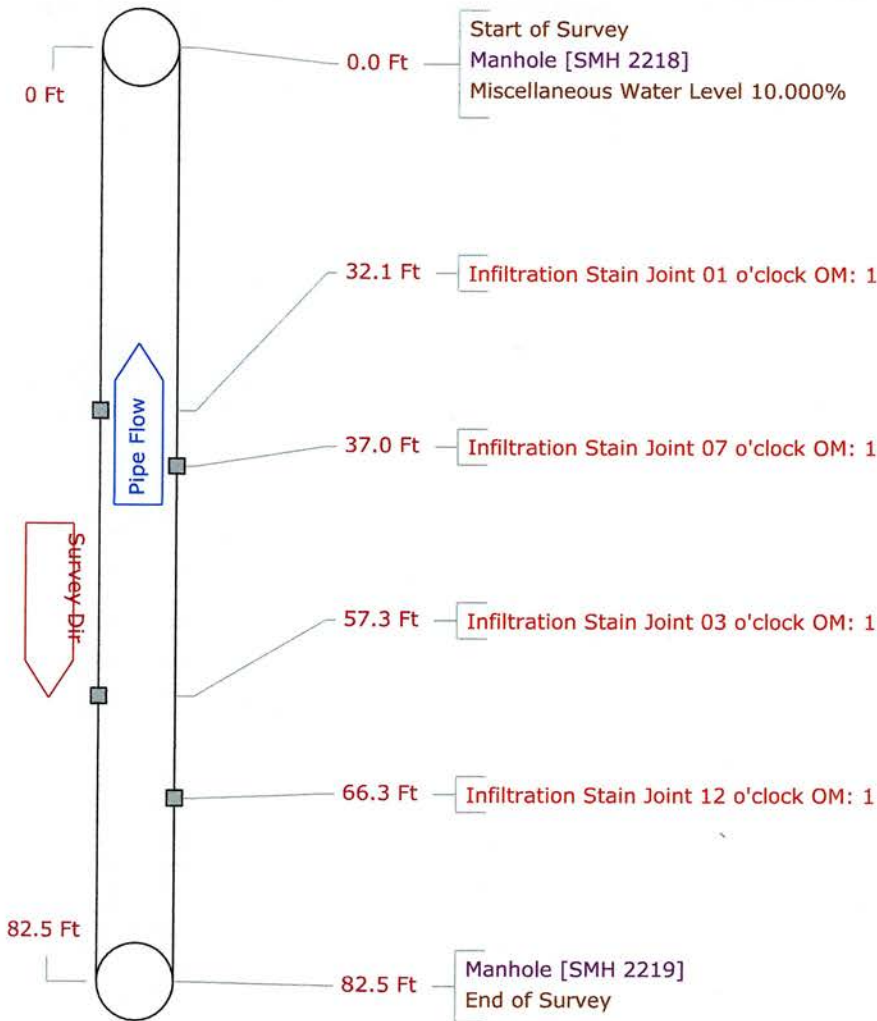
Tabular Report of PSR SMH 2219

Count	Video	CD Code	Val1	Val2	%	Jnt	Fr	To	ImRef	Remarks
0.0		ST								Start of Survey
0.0		AMH								Manhole
0.0		MWL			10.000					Miscellaneous Water Level
32.1		ISJ				J	01			Infiltration Stain Joint
37.0		ISJ				J	07			Infiltration Stain Joint
57.3		ISJ				J	03			Infiltration Stain Joint
66.3		ISJ				J	12			Infiltration Stain Joint
82.5		AMH								Manhole
82.5		FH								End of Survey

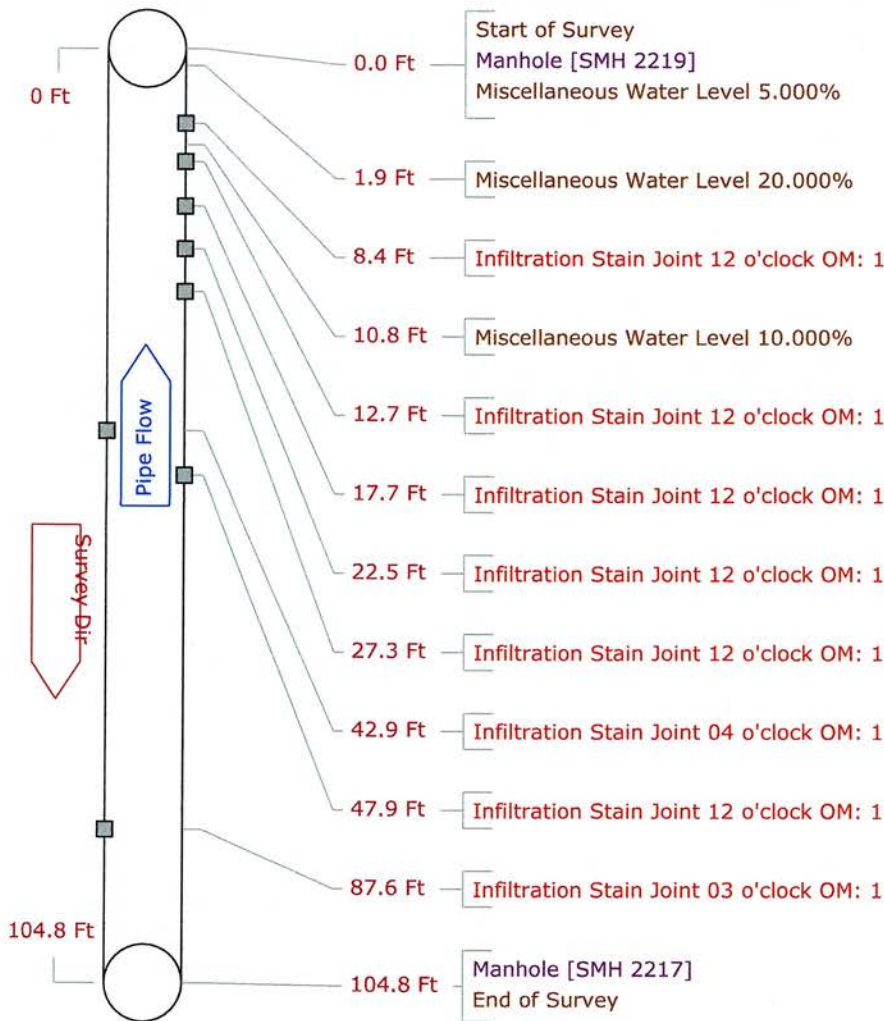
Tabular Report of PSR SMH 2217

Count	Video	CD Code	Val1	Val2	%	Jnt	Fr	To	ImRef	Remarks
0.0		ST Start of Survey								
0.0		AMH Manhole								SMH 2219
0.0		MWL Miscellaneous Water Level			5.000					
1.9		MWL Miscellaneous Water Level			20.000					
8.4		ISJ Infiltration Stain Joint				J	12			
10.8		MWL Miscellaneous Water Level			10.000					
12.7		ISJ Infiltration Stain Joint				J	12			
17.7		ISJ Infiltration Stain Joint				J	12			
22.5		ISJ Infiltration Stain Joint				J	12			
27.3		ISJ Infiltration Stain Joint				J	12			
42.9		ISJ Infiltration Stain Joint				J	04			
47.9		ISJ Infiltration Stain Joint				J	12			
87.6		ISJ Infiltration Stain Joint				J	03			
104.8		AMH Manhole								SMH 2217
104.8		FH End of Survey

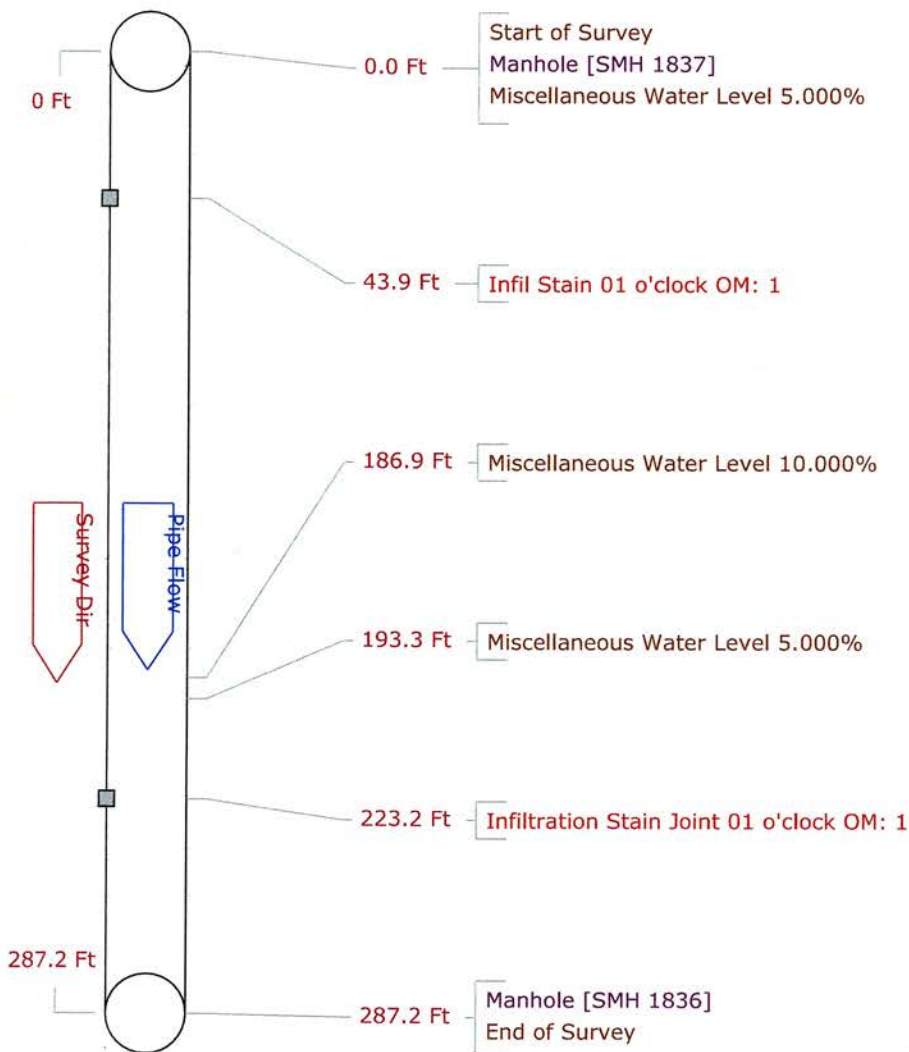
Tabular Report of PSR SMH 1837

Count Video	CD Code	Val1	Val2	%	Jnt	Fr	To	ImRef	Remarks
0.0	ST								Start of Survey
0.0	AMH								Manhole SMH 1837
0.0	MWL			5.000					Miscellaneous Water Level
43.9	IS					01			Infil Stain
186.9	MWL			10.000					Miscellaneous Water Level
193.3	MWL			5.000					Miscellaneous Water Level
223.2	ISJ				J	01			Infiltration Stain Joint
287.2	AMH								Manhole SMH 1836
287.2	FH								End of Survey

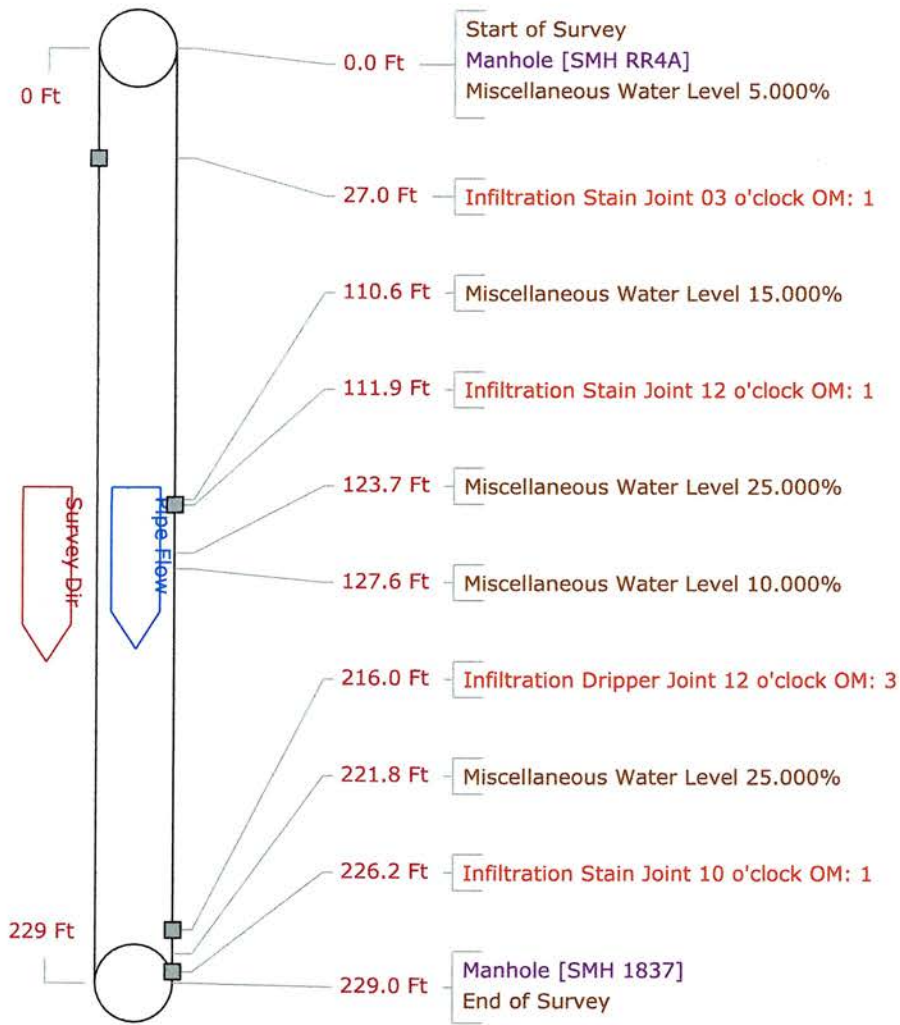
Tabular Report of PSR SMH RR4A for Liden Engineering

Count Video	CD Code	Val1	Val2	%	Jnt	Fr	To	ImRef	Remarks
0.0	ST								Start of Survey
0.0	AMH								Manhole SMH RR4A
0.0	MWL			5.000					Miscellaneous Water Level
27.0	ISJ				J	03			Infiltration Stain Joint
110.6	MWL			15.000					Miscellaneous Water Level
111.9	ISJ				J	12			Infiltration Stain Joint
123.7	MWL			25.000					Miscellaneous Water Level
127.6	MWL			10.000					Miscellaneous Water Level
216.0	IDJ				J	12			Infiltration Dripper Joint
221.8	MWL			25.000					Miscellaneous Water Level
226.2	ISJ				J	10			Infiltration Stain Joint
229.0	AMH								Manhole SMH 1837
229.0	FH								End of Survey

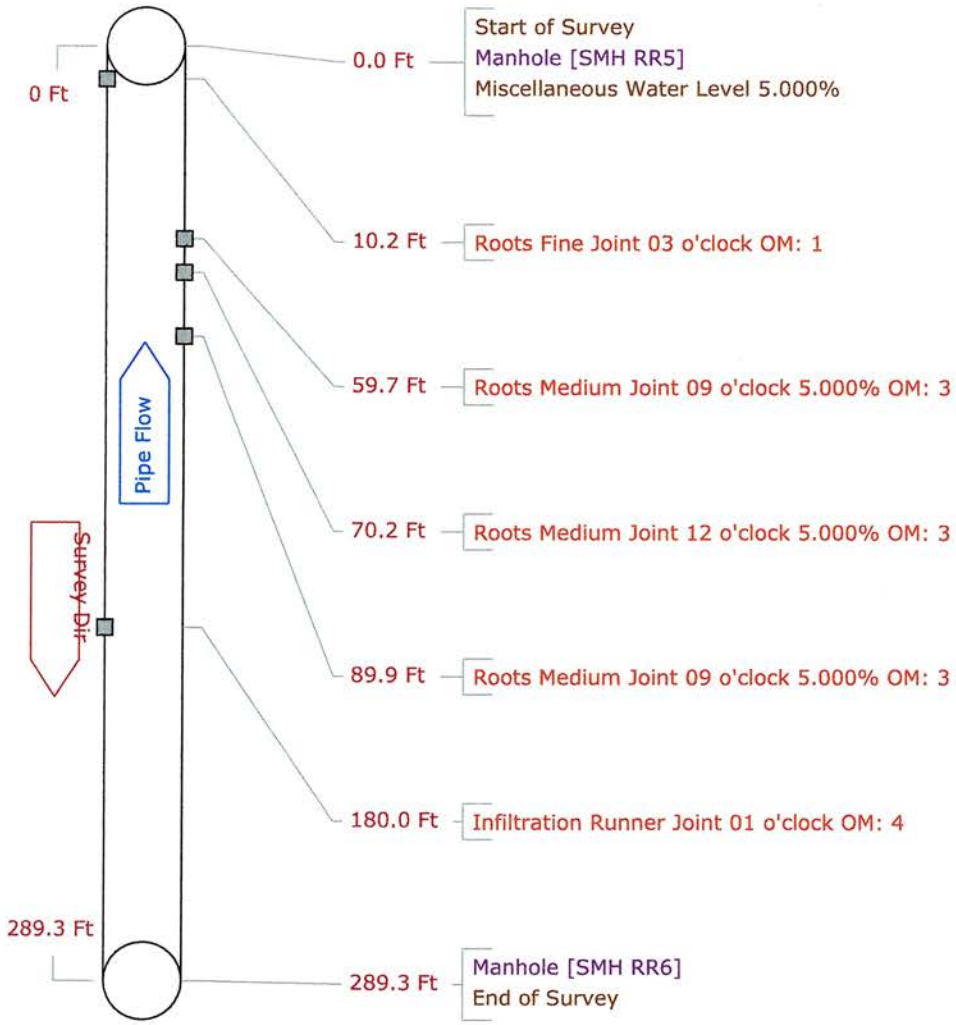
Tabular Report of PSR SMH RR6 for Liden Engineering

Count Video	CD Code	Val1	Val2	%	Jnt	Fr To	ImRef	Remarks
0.0	ST							Start of Survey
0.0	AMH							Manhole SMH RR5
0.0	MWL			5.000				Miscellaneous Water Level
10.2	RFJ				J	03		Roots Fine Joint
59.7	RMJ			5.000	J	09		Roots Medium Joint
70.2	RMJ			5.000	J	12		Roots Medium Joint
89.9	RMJ			5.000	J	09		Roots Medium Joint
180.0	IRJ				J	01		Infiltration Runner Joint
289.3	AMH							Manhole SMH RR6
289.3	FH							End of Survey

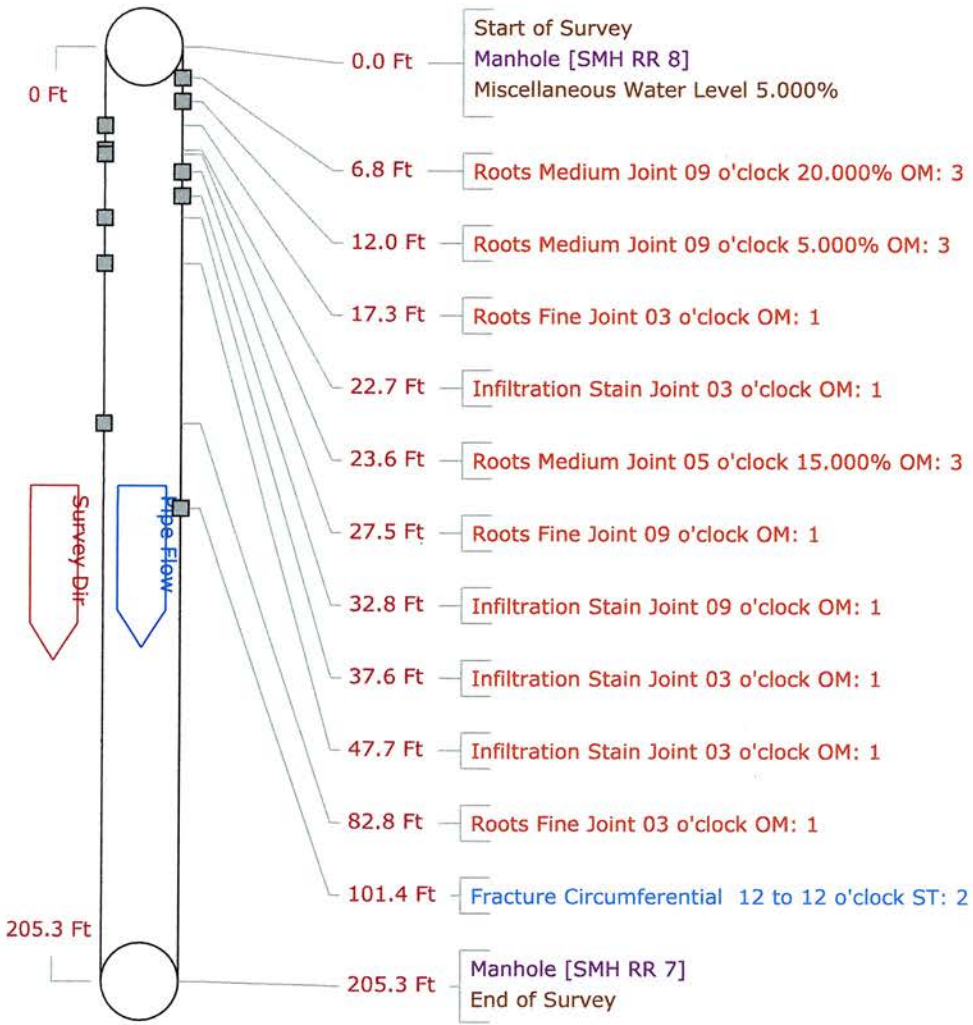
Tabular Report of PSR SMH RR 8 for Liden Engineering

Count	Video	CD Code	Val1	Val2	%	Jnt	Fr	To	ImRef	Remarks
0.0		ST								Start of Survey
0.0		AMH								Manhole SMH RR 8
0.0		MWL			5.000					Miscellaneous Water Level
6.8		RMJ			20.000	J	09			Roots Medium Joint
12.0		RMJ			5.000	J	09			Roots Medium Joint
17.3		RFJ				J	03			Roots Fine Joint
22.7		ISJ				J	03			Infiltration Stain Joint
23.6		RMJ			15.000	J	05			Roots Medium Joint
27.5		RFJ				J	09			Roots Fine Joint
32.8		ISJ				J	09			Infiltration Stain Joint
37.6		ISJ				J	03			Infiltration Stain Joint
47.7		ISJ				J	03			Infiltration Stain Joint
82.8		RFJ				J	03			Roots Fine Joint
101.4		FC					12	12		Fracture Circumferential
205.3		AMH								Manhole SMH RR 7
205.3		FH								End of Survey

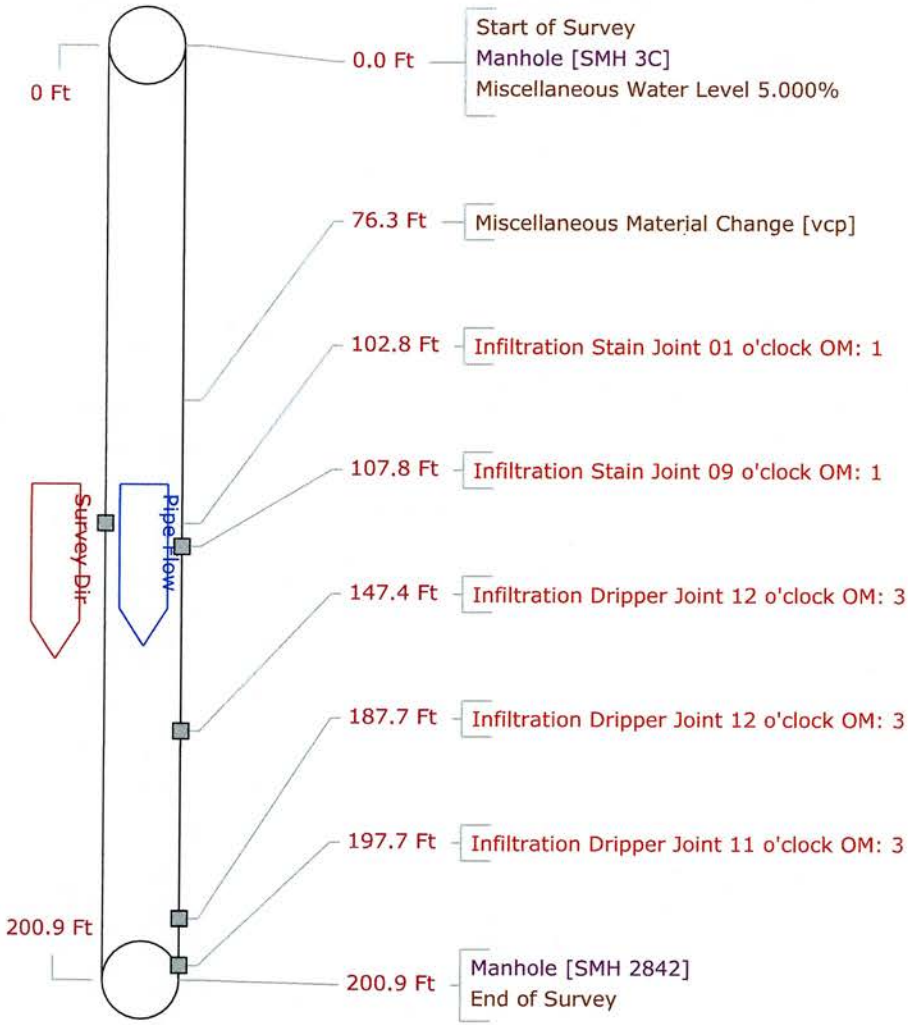
Tabular Report of PSR SMH 3C for Liden Engineering

Count Video	CD Code	Val1	Val2	%	Jnt	Fr	To	ImRef	Remarks
0.0	ST								Start of Survey
0.0	AMH								Manhole SMH 3C
0.0	MWL			5.000					Miscellaneous Water Level
76.3	MMC								Miscellaneous Material Change vcp
102.8	ISJ				J	01			Infiltration Stain Joint
107.8	ISJ				J	09			Infiltration Stain Joint
147.4	IDJ				J	12			Infiltration Dripper Joint
187.7	IDJ				J	12			Infiltration Dripper Joint
197.7	IDJ				J	11			Infiltration Dripper Joint
200.9	AMH								Manhole SMH 2842
200.9	FH								End of Survey

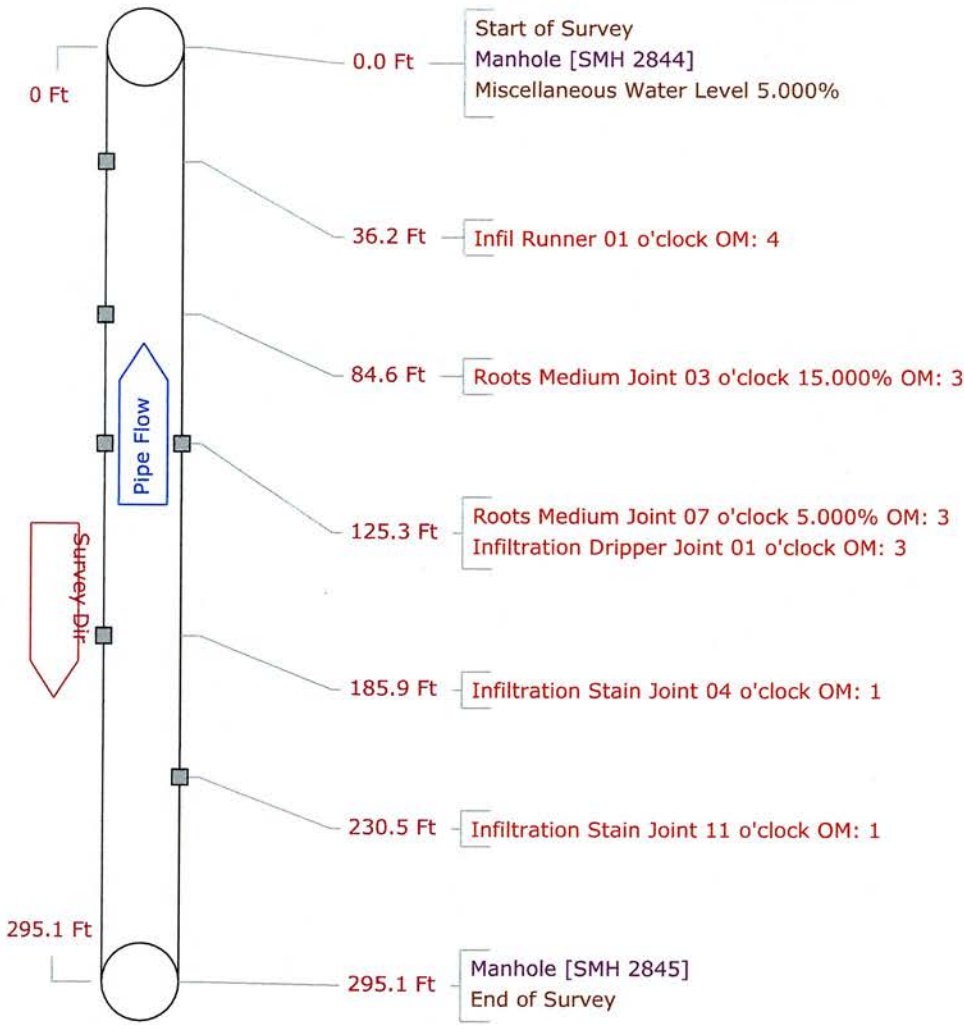
Tabular Report of PSR SMH 2845 for Liden Engineering

Count	Video	CD Code	Val1	Val2	%	Jnt	Fr	To	ImRef	Remarks
0.0		ST Start of Survey								
0.0		AMH Manhole								SMH 2844
0.0		MWL Miscellaneous Water Level			5.000					
36.2		IR Infil Runner					01			
84.6		RMJ Roots Medium Joint			15.000	J	03			
125.3		RMJ Roots Medium Joint			5.000	J	07			
125.3		IDJ Infiltration Dripper Joint				J	01			
185.9		ISJ Infiltration Stain Joint				J	04			
230.5		ISJ Infiltration Stain Joint				J	11			
295.1		AMH Manhole								SMH 2845
295.1		FH End of Survey

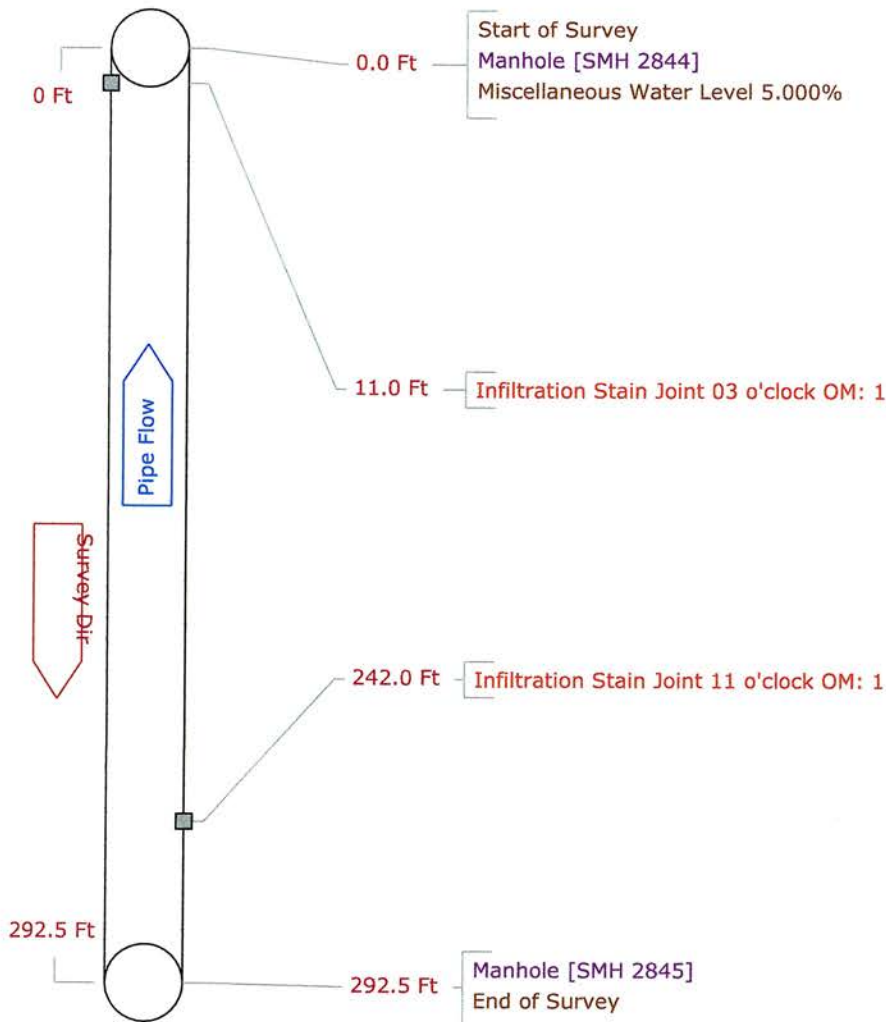
Tabular Report of PSR SMH 2845

Count	Video	CD Code	Val1	Val2	%	Jnt	Fr	To	ImRef	Remarks
0.0		ST								Start of Survey
0.0		AMH								Manhole SMH 2844
0.0		MWL			5.000					Miscellaneous Water Level
11.0		ISJ				J	03			Infiltration Stain Joint
242.0		ISJ				J	11			Infiltration Stain Joint
292.5		AMH								Manhole SMH 2845
292.5		FH								End of Survey

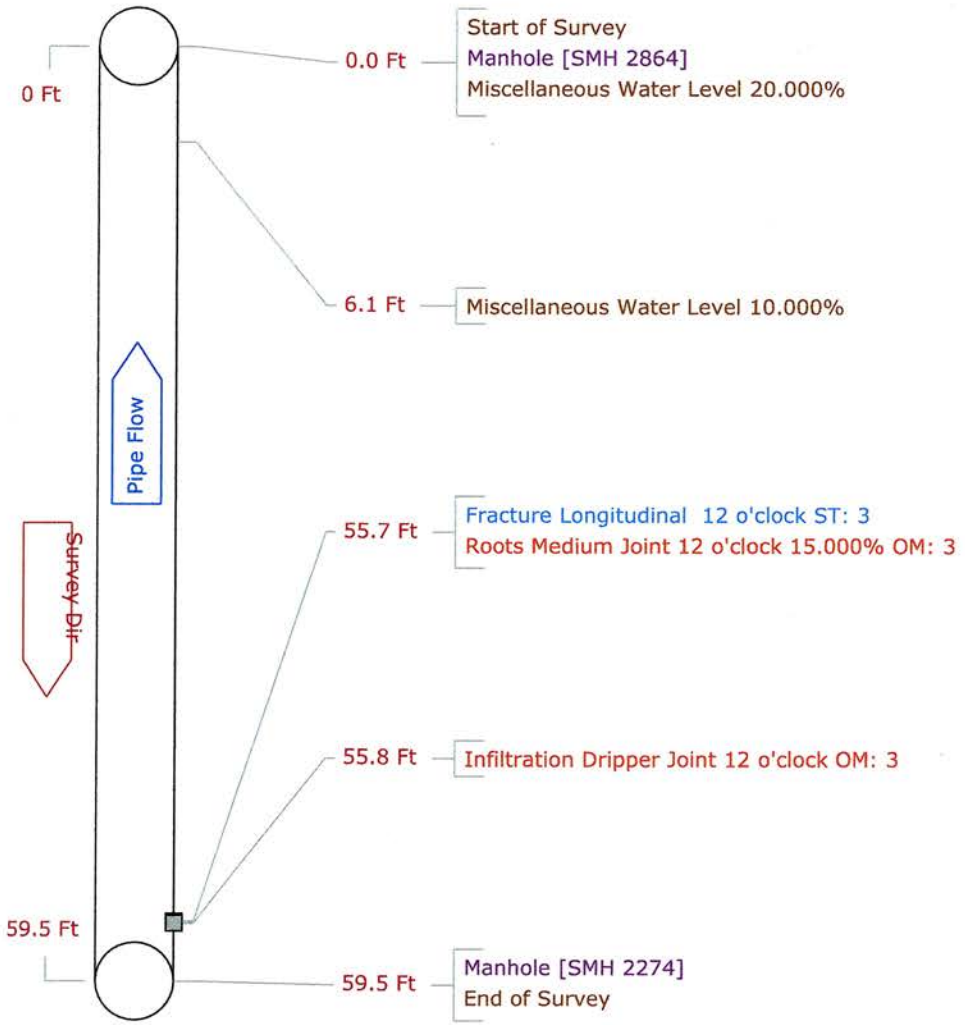
Tabular Report of PSR SMH 2274 for Liden Engineering

Count	Video	CD Code	Val1	Val2	%	Jnt	Fr	To	ImRef	Remarks
0.0		ST Start of Survey								
0.0		AMH Manhole								SMH 2864
0.0		MWL Miscellaneous Water Level			20.000					
6.1		MWL Miscellaneous Water Level			10.000					
55.7		FL Fracture Longitudinal					12			
55.7		RMJ Roots Medium Joint			15.000	J	12			
55.8		IDJ Infiltration Dripper Joint				J	12			
59.5		AMH Manhole								SMH 2274
59.5		FH End of Survey

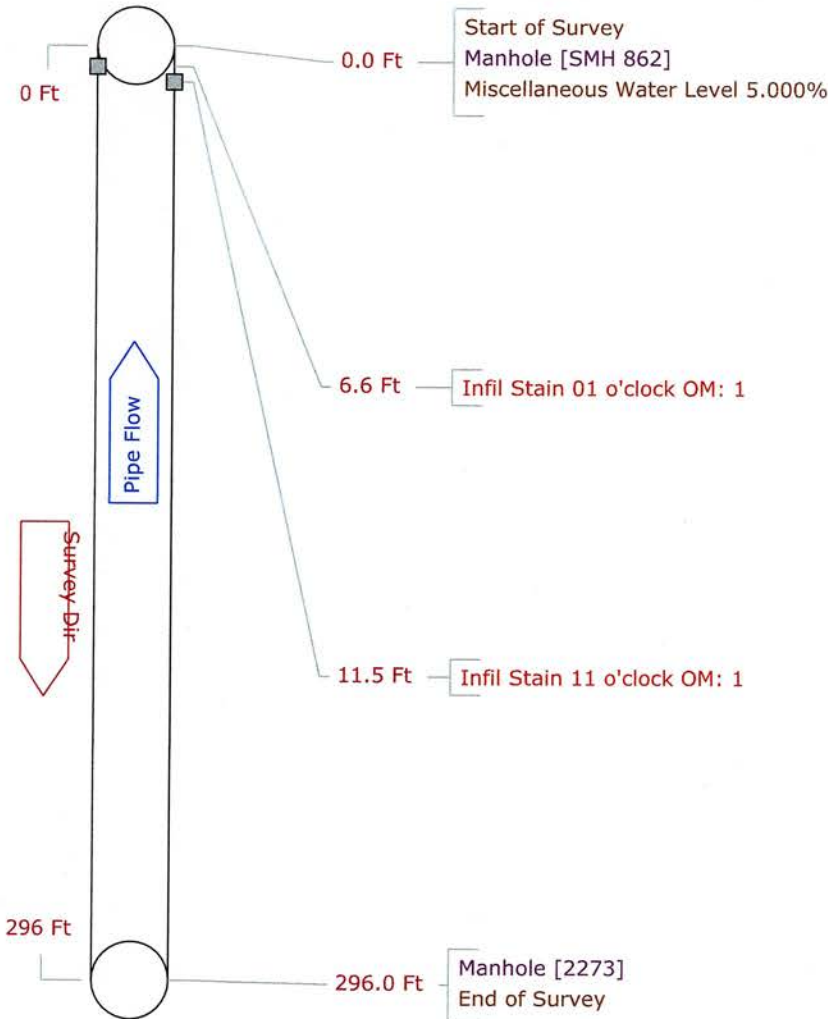
Tabular Report of PSR 2273 for Liden Engineering

Count Video	CD Code	Val1	Val2	%	Jnt	Fr	To	ImRef	Remarks
0.0	ST Start of Survey								
0.0	AMH Manhole								SMH 862
0.0	MWL Miscellaneous Water Level			5.000					
6.6	IS Infil Stain					01			
11.5	IS Infil Stain					11			
296.0	AMH Manhole								2273
296.0	FH End of Survey

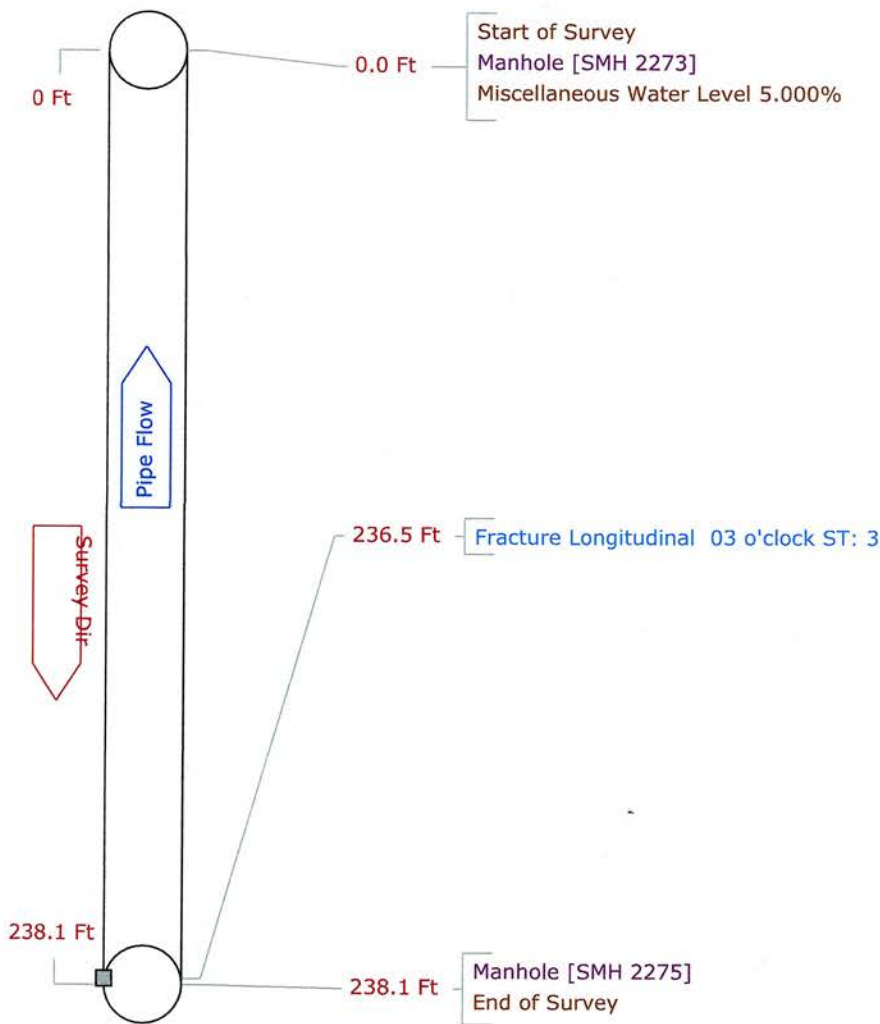
Tabular Report of PSR SMH 2275

Count	Video	CD Code	Val1	Val2	%	Jnt	Fr	To	ImRef	Remarks
0.0		ST								Start of Survey
0.0		AMH								Manhole
0.0		MWL			5.000					Miscellaneous Water Level
236.5		FL					03			Fracture Longitudinal
238.1		AMH								Manhole
238.1		FH								End of Survey
