SANITARY SEWER SYSTEM INVESTIGATION

Minuteman and Shattuck Road area
Andover, MA

Sewer Video Investigation Conducted by:
BMC Corp., Billerica, MA

Coordinated by:
LINDEN ENGINEERING PARTNERS, LLC
100 TradeCenter, Suite G700
Woburn, MA 01801

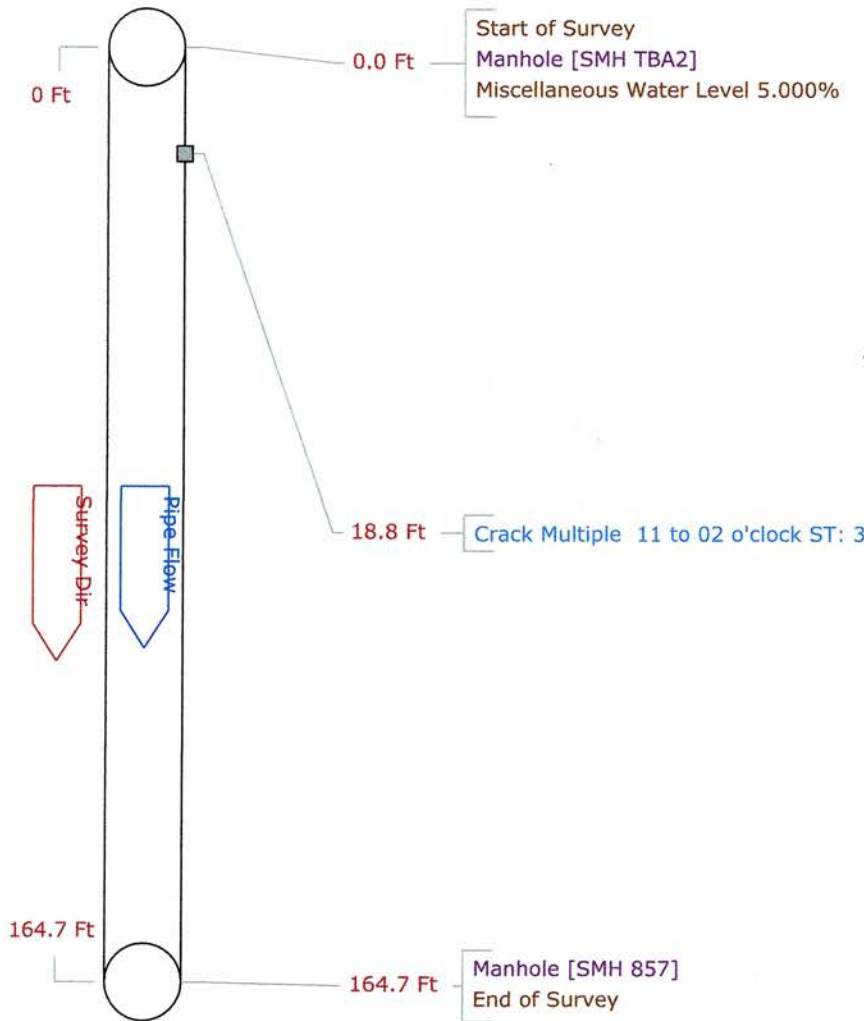
Tabular Report of PSR SMH TBA2 for Liden Engineering

Count	Video	CD Code	Val1	Val2	%	Jnt	Fr	To	ImRef	Remarks
0.0		ST								Start of Survey
0.0		AMH								Manhole
0.0		MWL			5.000					Miscellaneous Water Level
18.8		CM					11	02		Crack Multiple
164.7		AMH								Manhole
164.7		FH								End of Survey

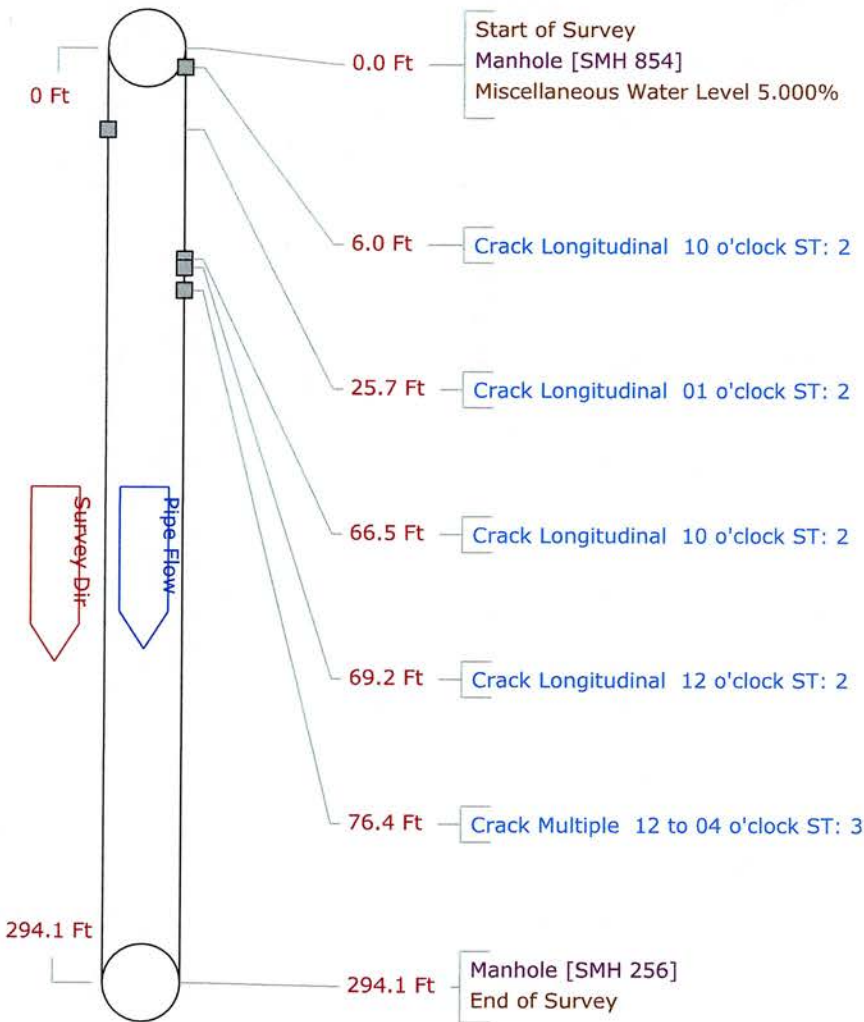
Tabular Report of PSR SMH 854 for Liden Engineering

Count	Video	CD Code	Val1	Val2	%	Jnt	Fr	To	ImRef	Remarks
0.0		ST Start of Survey								
0.0		AMH Manhole								SMH 854
0.0		MWL Miscellaneous Water Level			5.000					
6.0		CL Crack Longitudinal					10			
25.7		CL Crack Longitudinal					01			
66.5		CL Crack Longitudinal					10			
69.2		CL Crack Longitudinal					12			
76.4		CM Crack Multiple					12	04		
294.1		AMH Manhole								SMH 256
294.1		FH End of Survey

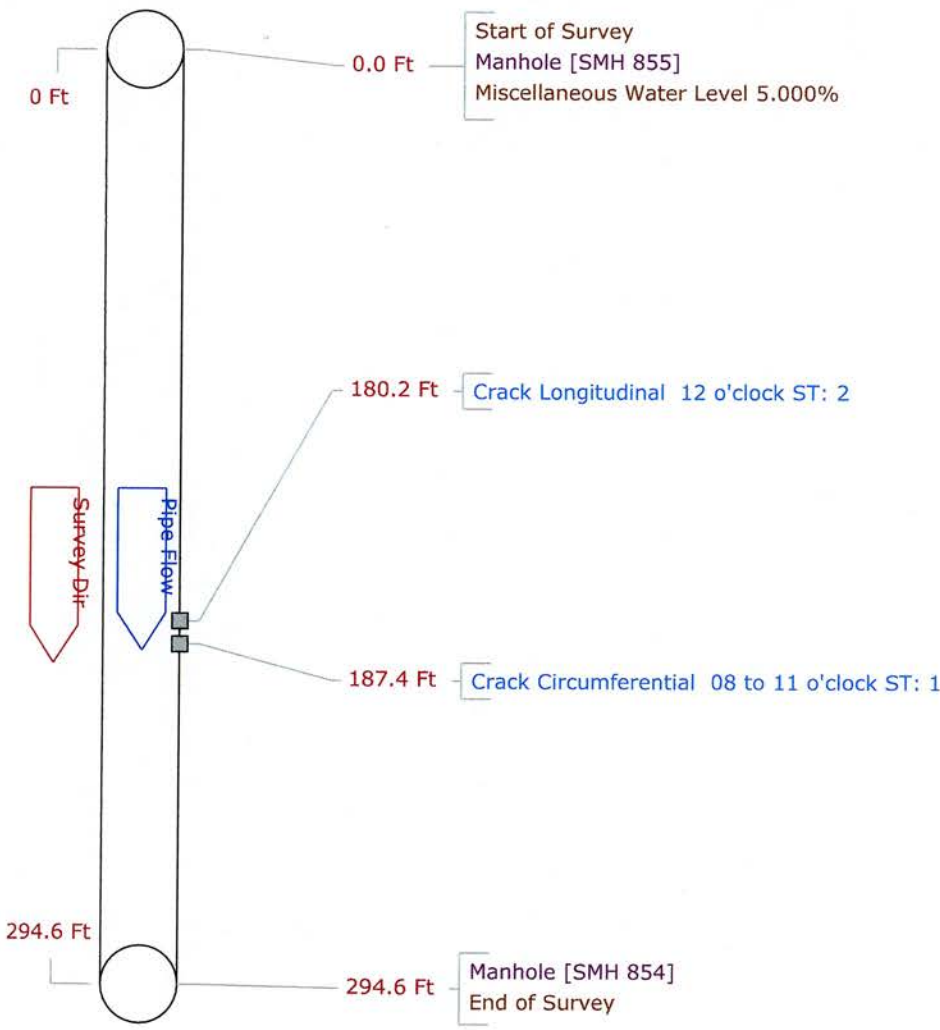
Tabular Report of PSR SMH 855

Count Video	CD Code	Val1	Val2	%	Jnt	Fr	To	ImRef	Remarks
0.0	ST								Start of Survey
0.0	AMH								Manhole
0.0	MWL			5.000					Miscellaneous Water Level
180.2	CL					12			Crack Longitudinal
187.4	CC					08	11		Crack Circumferential
294.6	AMH								Manhole
294.6	FH								End of Survey

Scores	Structural:	Pipe Rating 3	Pipe Ratings Index 1.5	Quick Rating 2111
	O&M:	Pipe Rating 0	Pipe Ratings Index 0	Quick Rating 0000
	Overall	Pipe Rating 3	Pipe Ratings Index 1.5	Quick Rating 2111

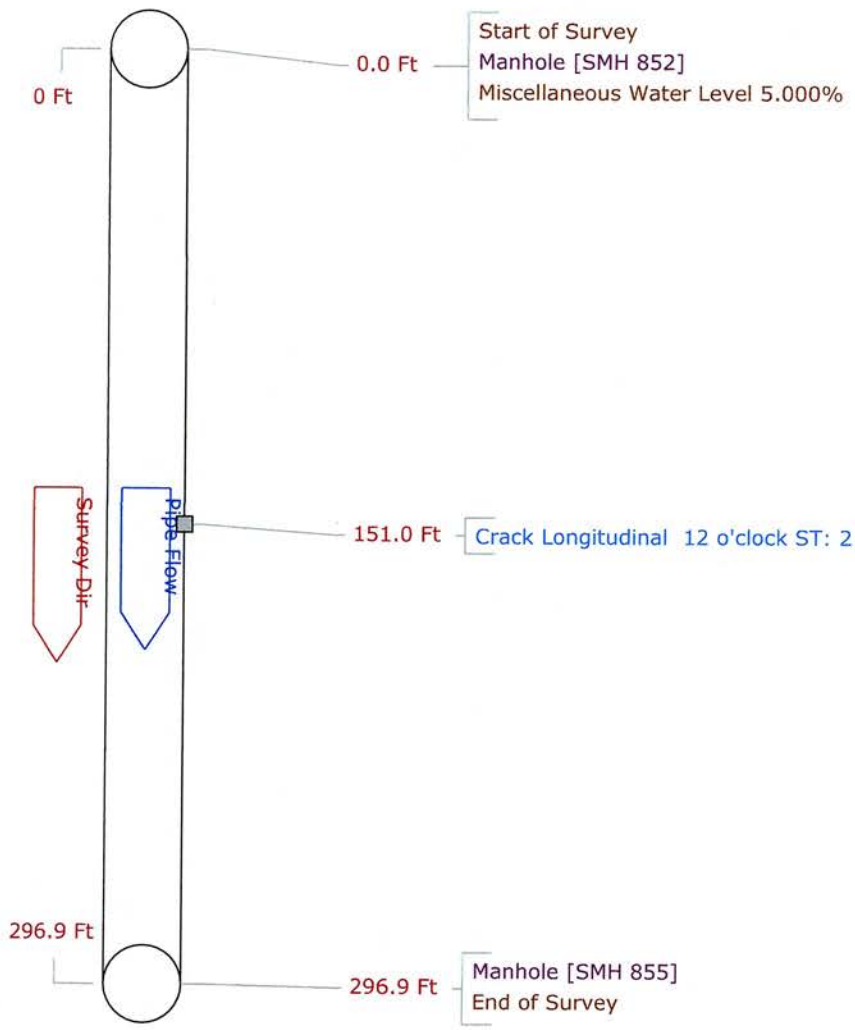
Tabular Report of PSR SMH 852

Count Video	CD Code	Val1	Val2	%	Jnt	Fr	To	ImRef	Remarks
0.0	ST								Start of Survey
0.0	AMH								Manhole SMH 852
0.0	MWL			5.000					Miscellaneous Water Level
151.0	CL					12			Crack Longitudinal
296.9	AMH								Manhole SMH 855
296.9	FH								End of Survey

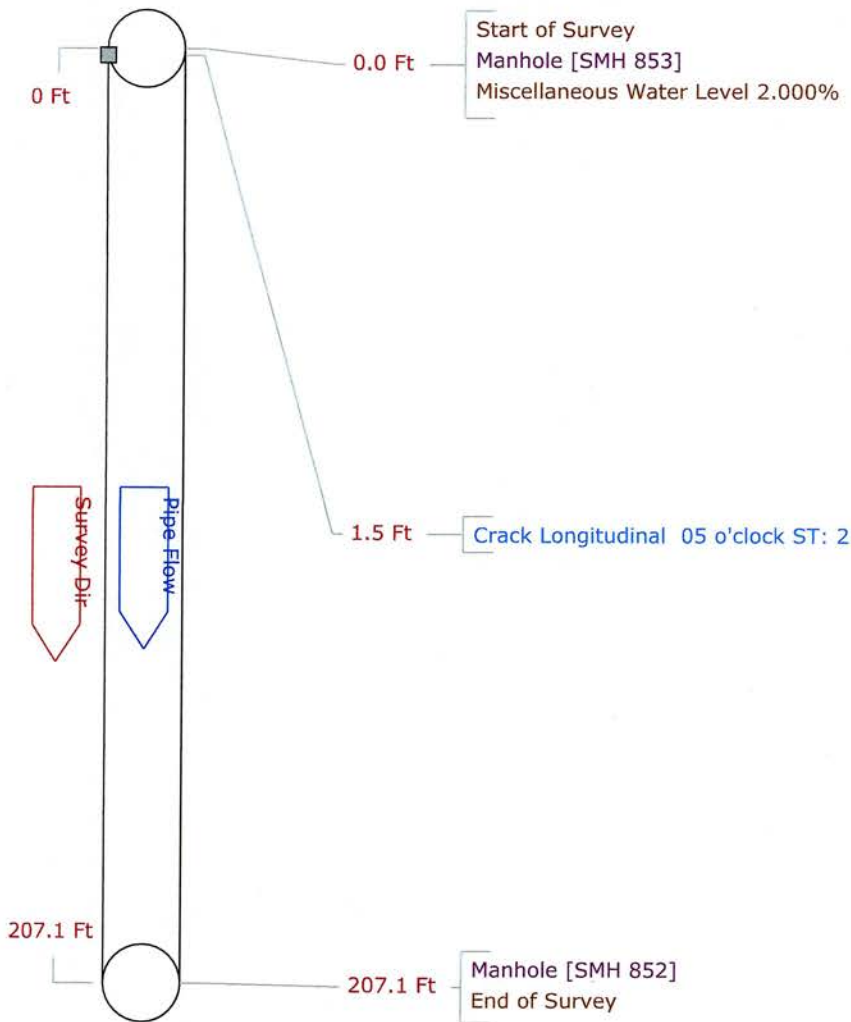
Tabular Report of PSR SMH 853 for Liden Engineering

Count Video	CD Code	Val1	Val2	%	Jnt	Fr	To	ImRef	Remarks
0.0	ST Start of Survey								
0.0	AMH Manhole								SMH 853
0.0	MWL Miscellaneous Water Level			2.000					
1.5	CL Crack Longitudinal					05			
207.1	AMH Manhole								SMH 852
207.1	FH End of Survey

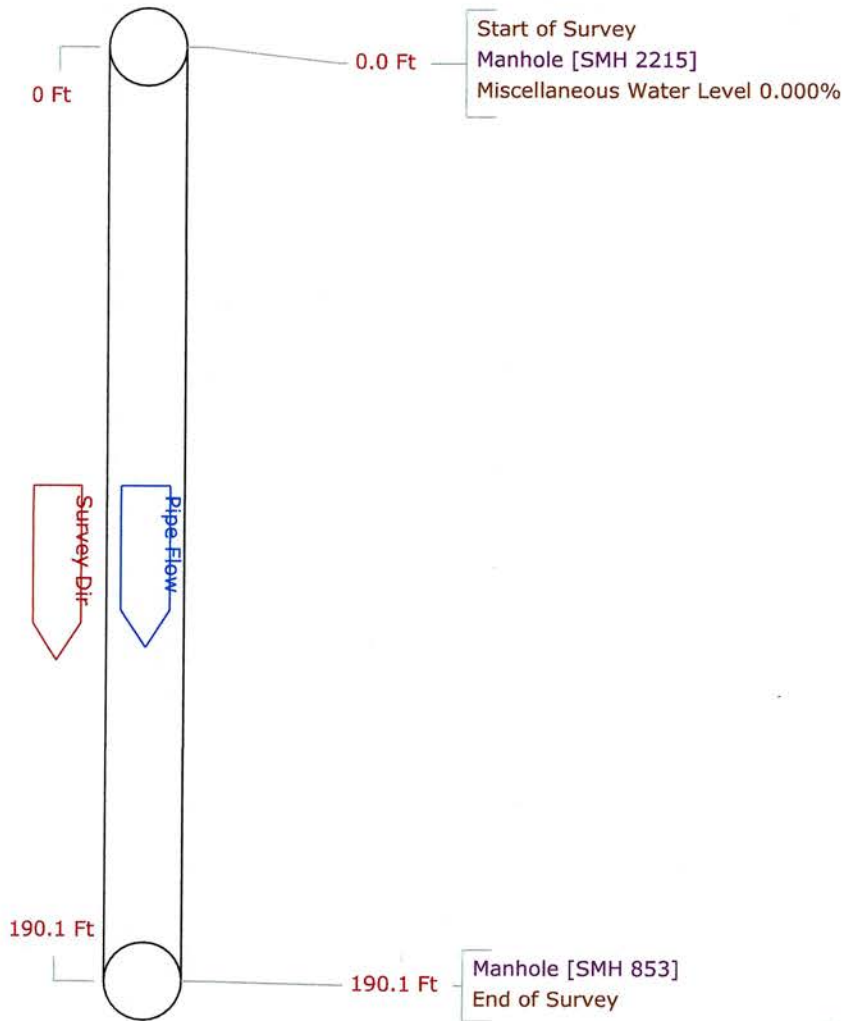
Tabular Report of PSR SMH 2215

Structural:	Pipe Rating	0	Pipe Ratings Index	0	Quick Rating	0000
O&M:	Pipe Rating	0	Pipe Ratings Index	0	Quick Rating	0000
Overall:	Pipe Rating	0	Pipe Ratings Index	0	Quick Rating	0000

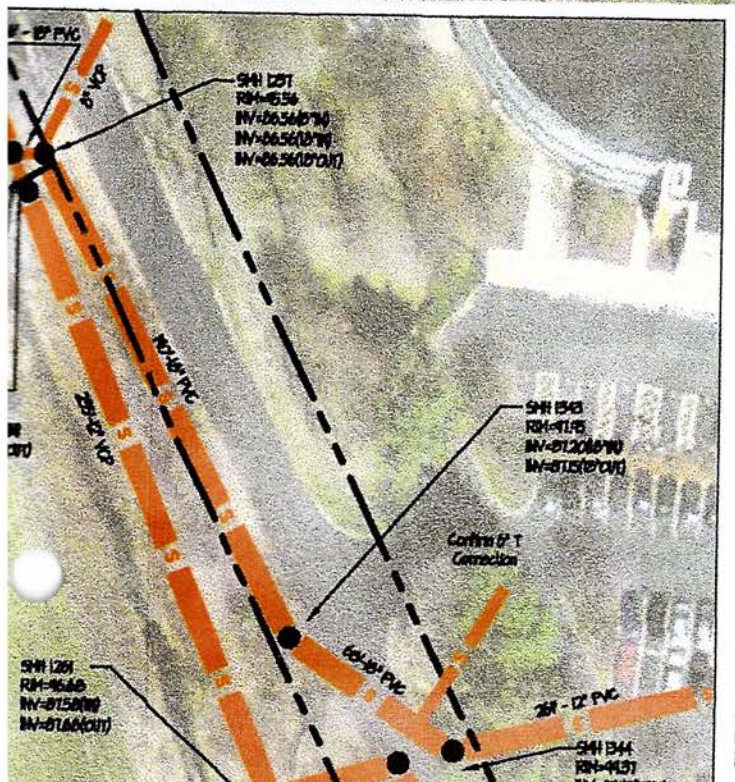
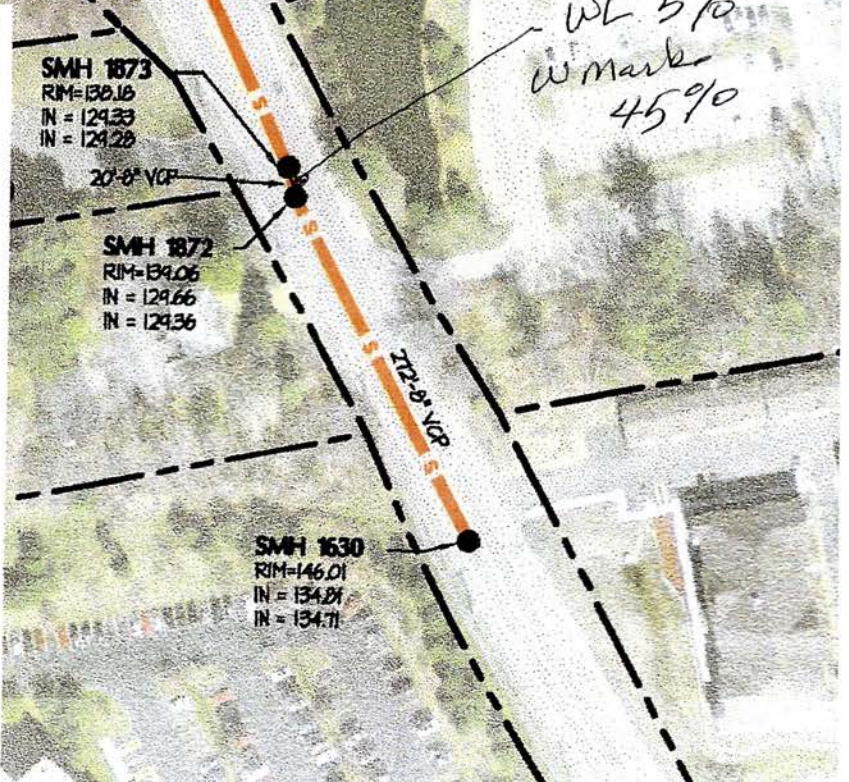
WL 5%
w mark
45%
