REPORT TO ACCOMPANY APPLICATION FOR SPECIAL PERMIT FOR EARTH MOVEMENT

Ministers Estates ~ 39 Sunset Rock Road, Andover, Massachusetts

Hydrologic Soil Group—Essex County, Massachusetts, Northern Part
(39 Sunset Rock Road)

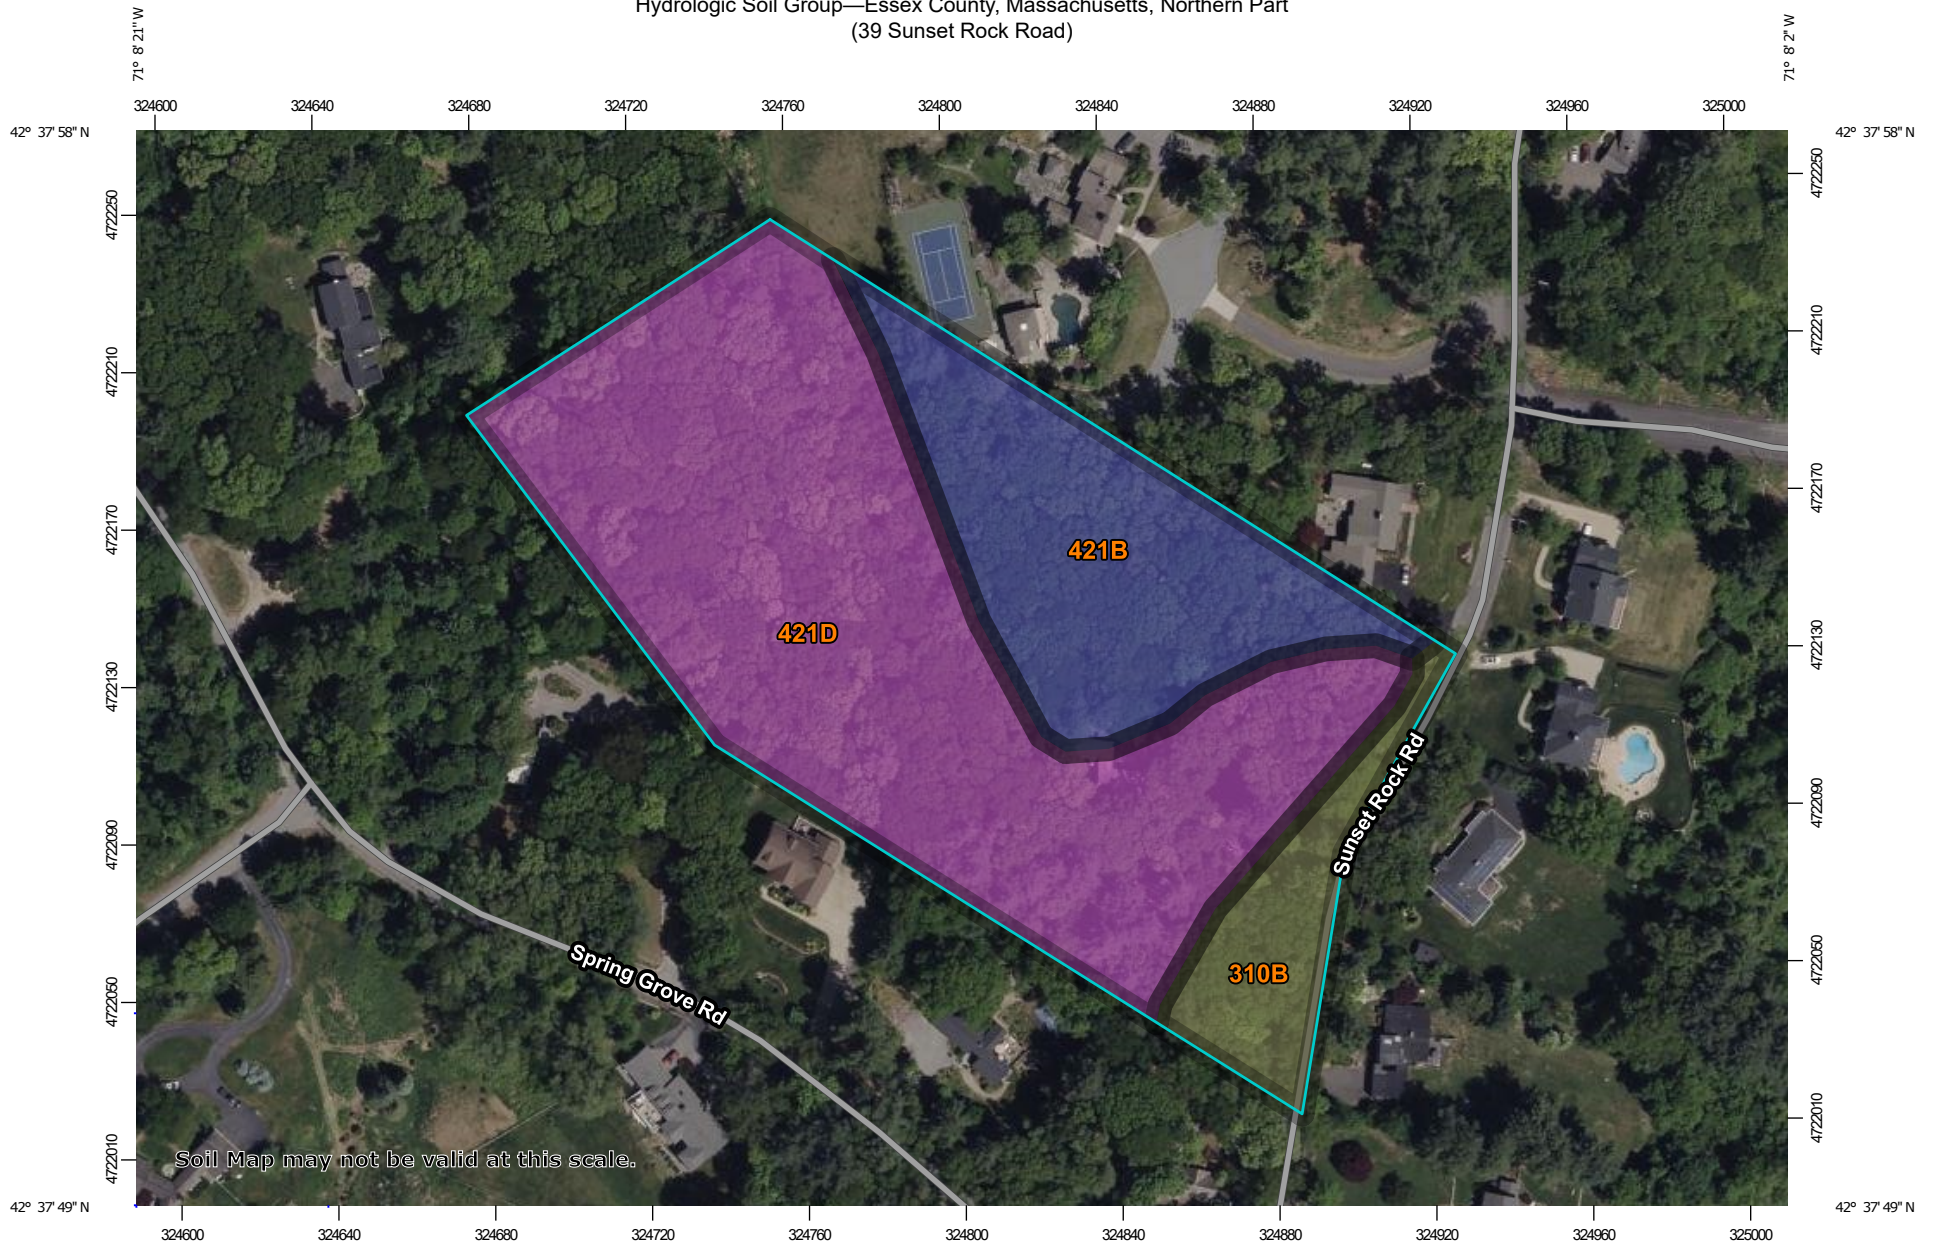
Map unit symbol	Map unit name	Rating	Acres in AOI	Percent of AOI
310B	Woodbridge fine sandy loam, 3 to 8 percent slopes	C/D	0.6	9.4%
421B	Canton fine sandy loam, 0 to 8 percent slopes, very stony	B	1.7	25.3%
421D	Canton fine sandy loam, 15 to 25 percent slopes, very stony	A	4.4	65.3%
Totals for Area of Interest			6.7	100.0%

Hydrologic soil groups are based on estimates of runoff potential. Soils are assigned to one of four groups according to the rate of water infiltration when the soils are not protected by vegetation, are thoroughly wet, and receive precipitation from long-duration storms.

The soils within the project consist of the Canton and Woodbridge series. Refer to the Soils Map at the end of this report and the Existing Conditions Plan (Definitive Subdivision Plan Set, Sheets 3 of 7).
